Report on the investigation of the grounding of

Transocean Winner

following the loss of tow from

8 August 2016

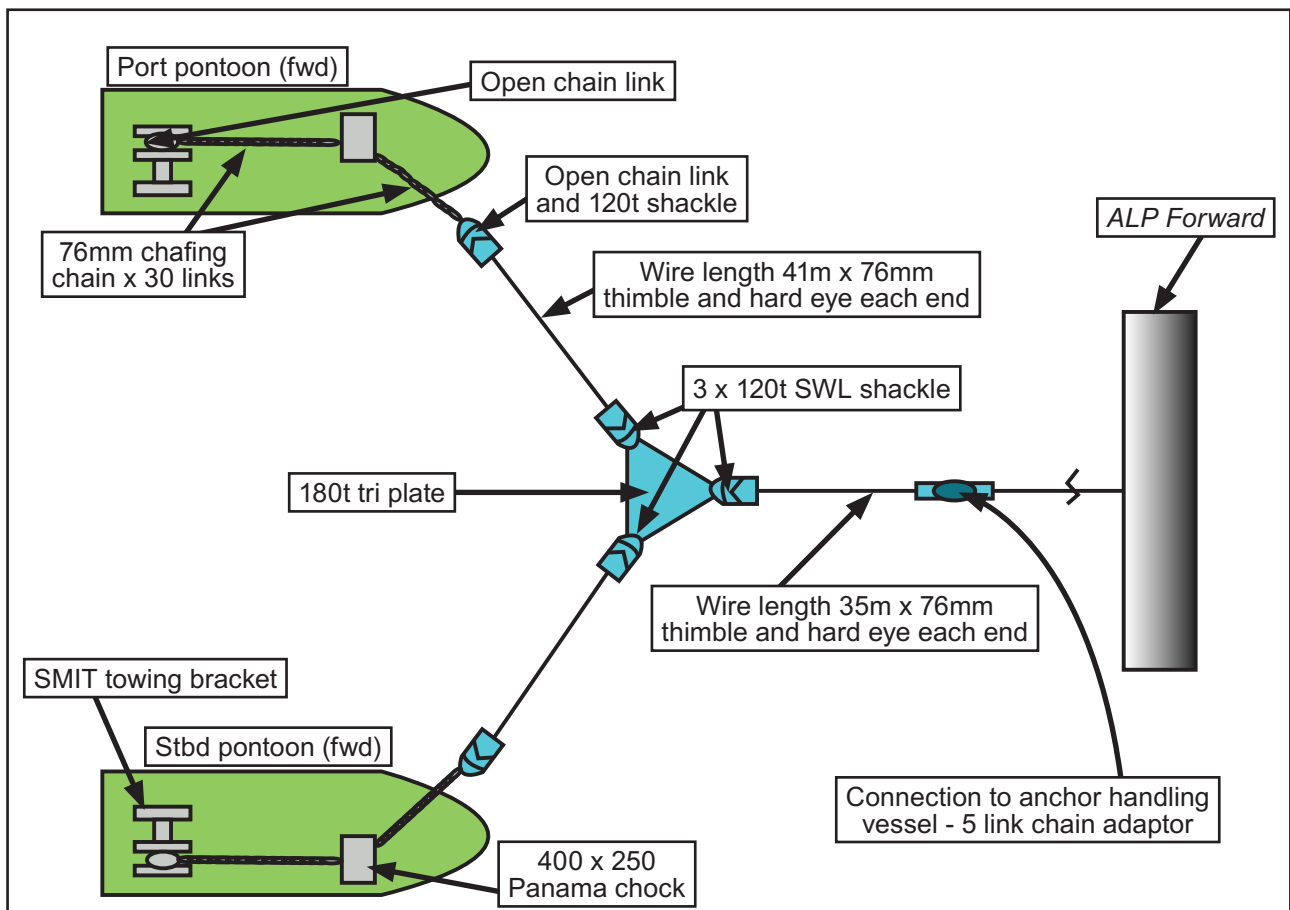
Figure 1: *Transocean Winner* main towing arrangement

Throughout the evening and during the early hours of the next day, the tug and tow continued to be blown towards the Isle of Lewis. The wind had backed a little to the west, but it remained at gale force. At 0236 the wind had dropped sufficiently for them to make headway, and the master lengthened the tow line to 740m and manoeuvred west, away from the coastline. At 0421 the tow line between *ALP Forward* and *Transocean Winner* failed 123m from the connection between the two vessels (**Figure 1**).

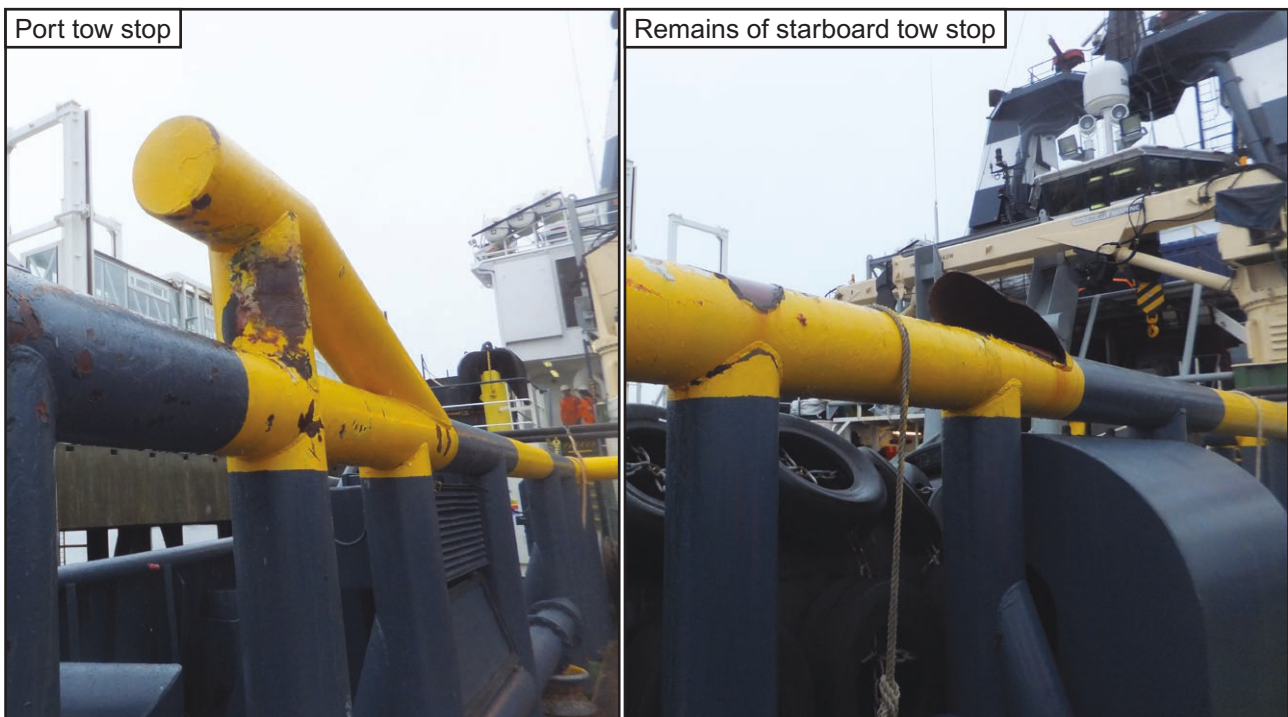
Figure 5: Port and starboard tow stops

Place on board	Vessel	Vessel
Injuries/fatalities	None	None
Damage/environmental impact	Tow stops damaged and main tow line broken	Pontoons damaged on grounding and 53m ³ diesel lost
Ship operation	Towing	Under tow
Voyage segment	Mid-water	Mid-water
External & internal environment	North-west near-gale force winds, rough to very rough seas, dark, poor visibility	
Persons on board	17	None

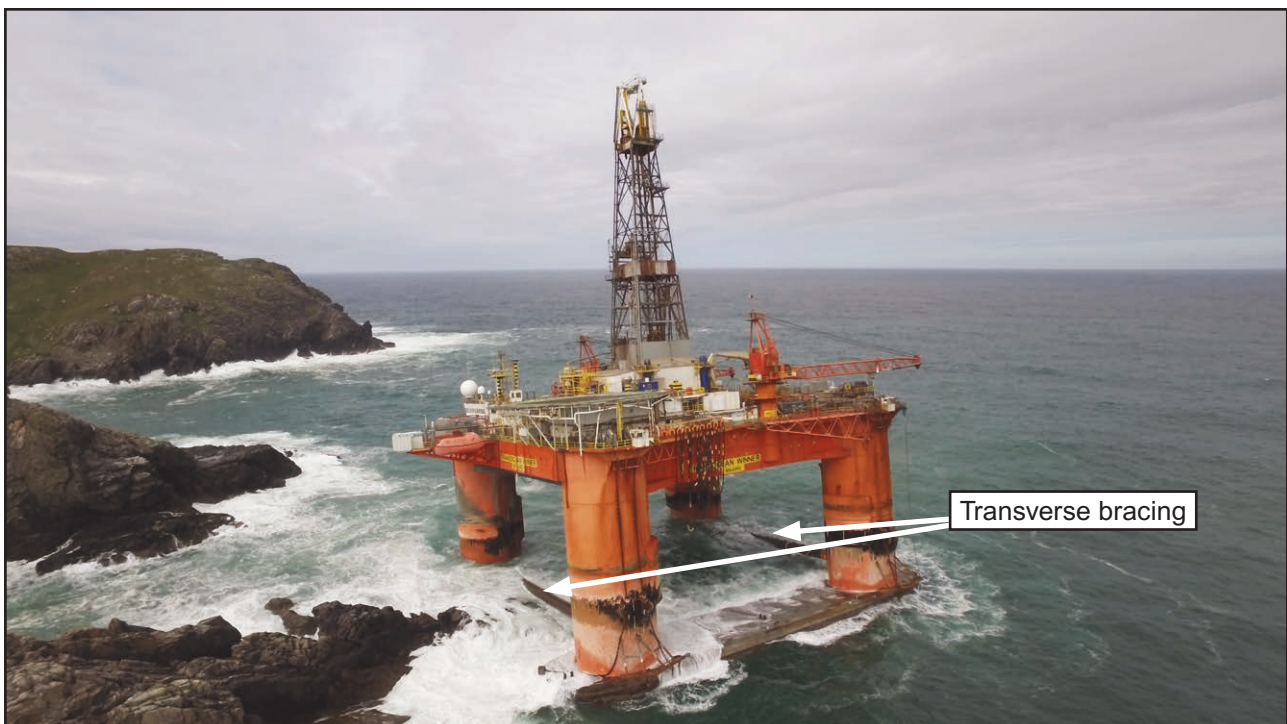
Figure 6: *Transocean Winner* aground

Immediately after *Transocean Winner* had grounded, SOSREP oversaw the co-ordination of the salvage operations with Transocean's appointed salvors, SMIT, and the Maritime and Coastguard Agency (MCA). *Transocean Winner* had grounded on rocks and, as the rig moved in the rough seas, the fuel tanks in its starboard pontoon were damaged, releasing approximately 53m³ of diesel oil. This diesel oil was dispersed in the waves and there was no pollution on the shore.
