MA2017-9

**MARINE ACCIDENT
INVESTIGATION REPORT**

Vessel type and name: Cargo Ship BBC ASIA

Accident type: Death and injury of workers

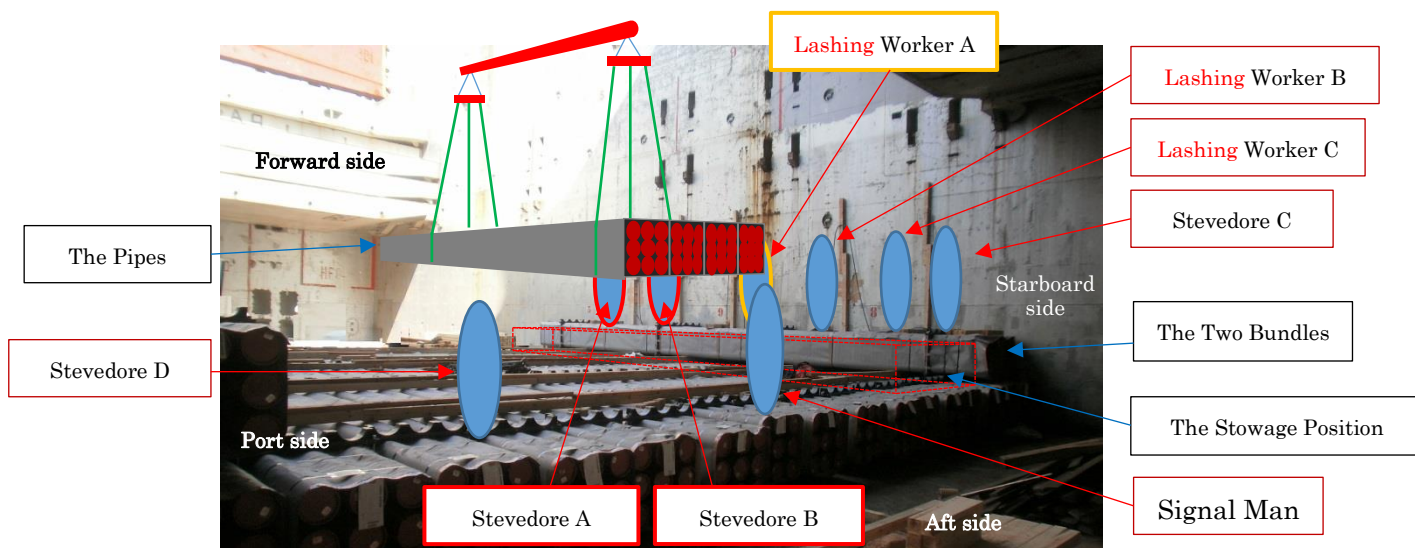
Photo 2.1-4 Arrangement of Workers at the Time of the Accident

Three stevedores (hereinafter referred to as “Stevedore A,” “Stevedore B,” and “Stevedore C”) waited on top of the Two Bundles for the purpose of adjusting the position of the Pipes from the starboard side of the Stowage Position, and three lashing workers (hereinafter referred to as “Lashing Worker A,” “Lashing Worker B,” and “Lashing Worker C”) were engaged in adding dunnage to the starboard wall on top of the Two Bundles.

The Signal Man instructed the Winchman to momentarily stop operating the crane by transceiver so that he could check the positions of the workers and the Stowage Position, having the Pipes stopped “at a position at which the Pipes’ starboard side was approximately three meters from the starboard wall and bottom was approximately two meters above the top of the first layer of Bundled Pipes” (hereinafter referred to as the “Stop Position”) (See Photo 2.1-4)

- (3) Depending on the vessel structure, type of cargo, etc., study work procedures that include refuge places and methods that anticipate hull-rolling-caused swinging of hoisted cargo and having workers enter a planned stowage position only after temporarily placing hoisted cargo on the floor and securing workers' safety, and make those procedures known to workers.

- (4) Based on the possibility that hoisted cargo may swing greatly as a result of hull rolling, etc., provide guidance to workers to ensure that they can execute their work in a manner that makes emergency responses possible; for example, by ascertaining continually changing cargo-handling conditions through constant monitoring of hoisted cargo and maintaining a posture that allows movement to previously studied refuge areas.

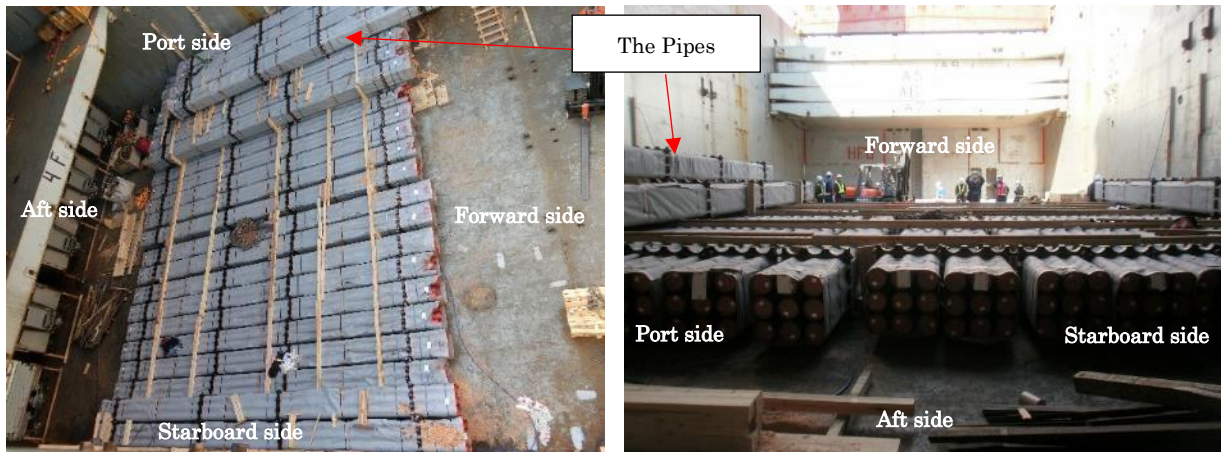
Figure 2.1-5 Circumstances Inside the No. 2 Cargo Hold After the Accident

The Winchman saw the Pipes hit workers and therefore instantly lifted the Pipes by operating the crane and placed them temporarily on top of Bundled Pipes that had been stowed on the port side. (See Photo 2.1-5)

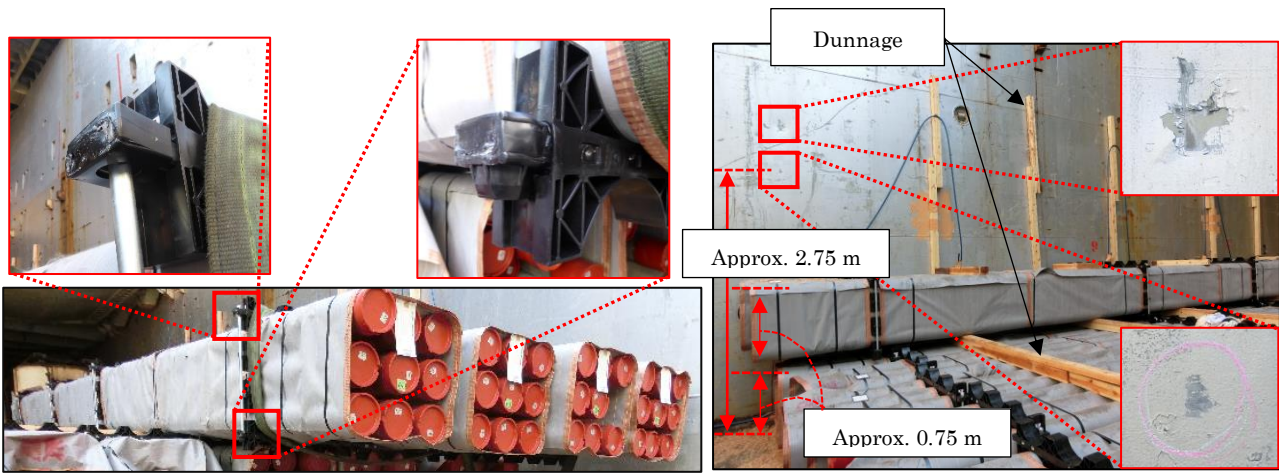
Photo 2.3-1 Pipe Cases

Vessel A had abrasions on the starboard wall of her No. 2 cargo hold. Eight bundles of Bundled Pipe, including the Pipes, also had abrasions. The location of the abrasions on the starboard wall of the No. 2 cargo hold was approximately 15.82 meters from the forward wall of the cargo hold and approximately 2.75 meters above the inner bottom plating. (See Photo 2.3-1 and Photo 2.3-2)

According to 2.3, it is highly probable that the accident caused abrasions on the starboard wall of Vessel A's No. 2 cargo hold and abrasions on eight bundles of Bundled Pipe, including the Pipes.

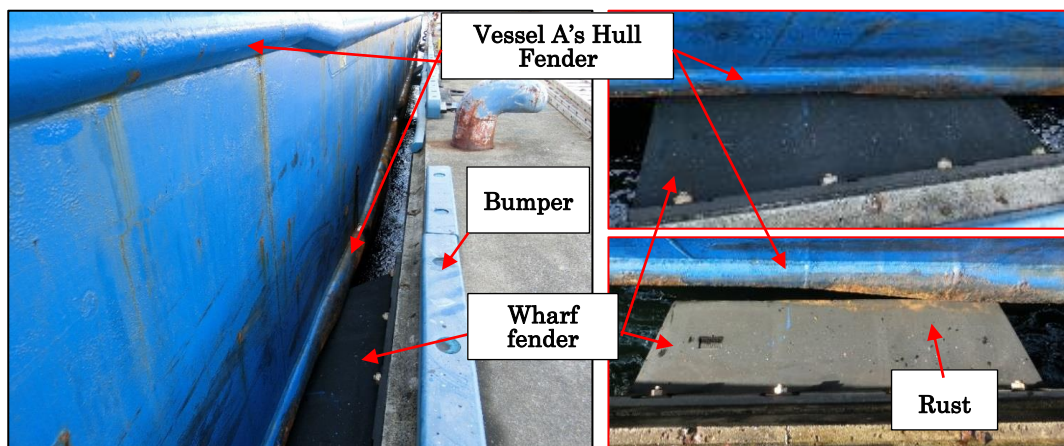
Photo 2.5-2 Fenders on the Wharf

At around 13:00 on November 1, with a height of tide (end of outgoing tide) and draft equivalent to those at the time of the accident, the underside of Vessel A's starboard-side Hull Fender contacted with and became caught on the tops of three fenders on the Wharf at approximately 30 meters, 49.6 meters, and 69.4 meters from Vessel A's stern end toward the bow. When the underside of the Hull Fender came off the tops of the wharf fenders, Vessel A's hull inclined toward the starboard side and rolled several times. Additionally, rust from the underside of Vessel A's Hull Fender was on the tops of the fenders on the Wharf. (See Photo 2.5-2)

- (2) Demand that crew members of vessels with fenders installed on the hull sides cooperate in preventing hull rolling caused by the catching of hull fenders and wharf fenders by, for example, holding meetings prior to the start of cargo-handling and adjusting draft to the tide so that catching does not occur.

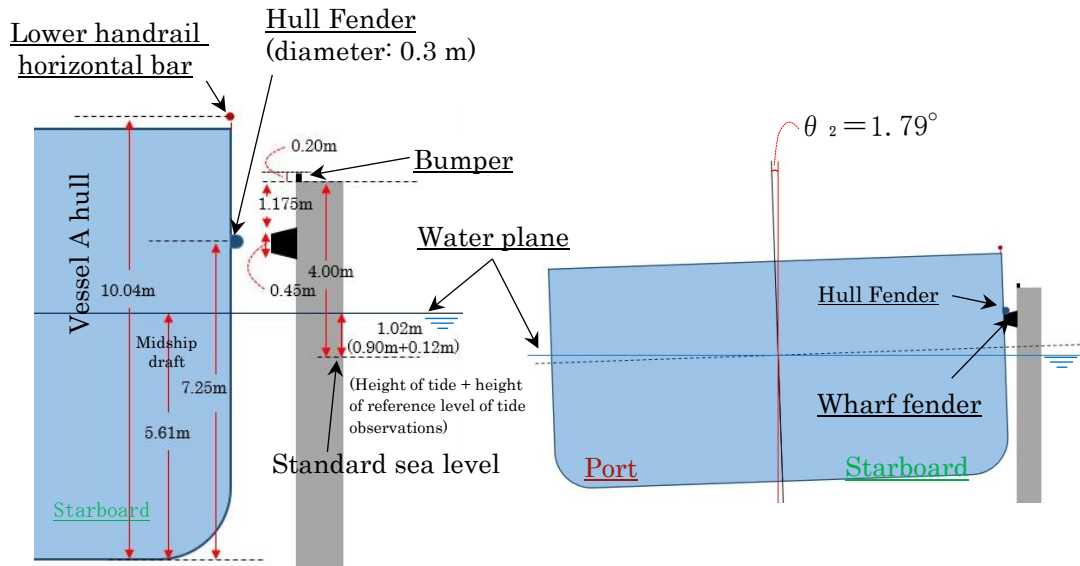
Figure 2.9-1 Positional Relationship between the Hull and Wharf

The positional relationship between the hull and the wharf is as shown in Figure 2.9-1. The hull inclination angle θ_2 is approximately 1.79° to the port side.

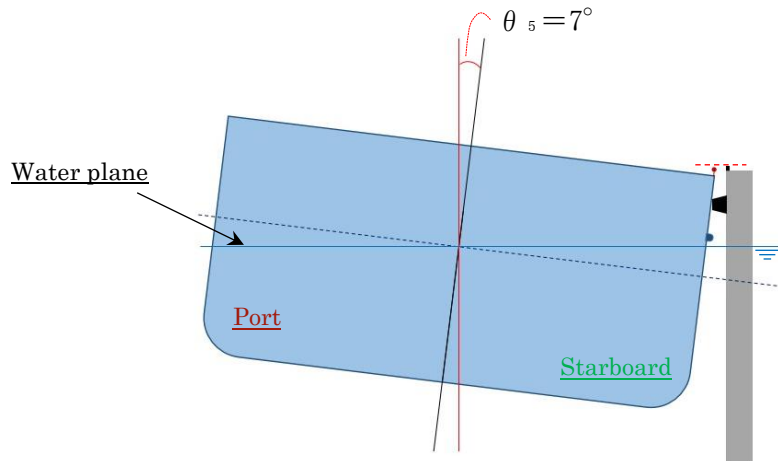
Figure 2.9-2 Circumstances of the Hull Inclination Angle at the Time of the Accident

According to the statement of Stevedore F, the hull inclination angle at the time of the accident was in a state in which the lower horizontal bar of the handrail installed on Vessel A's starboard upper deck was roughly at the same height as the Wharf's bumper. This would make hull inclination angle θ_5 7° to the starboard side, which roughly matches inclination angle θ_4 . (See Figure 2.9-2)

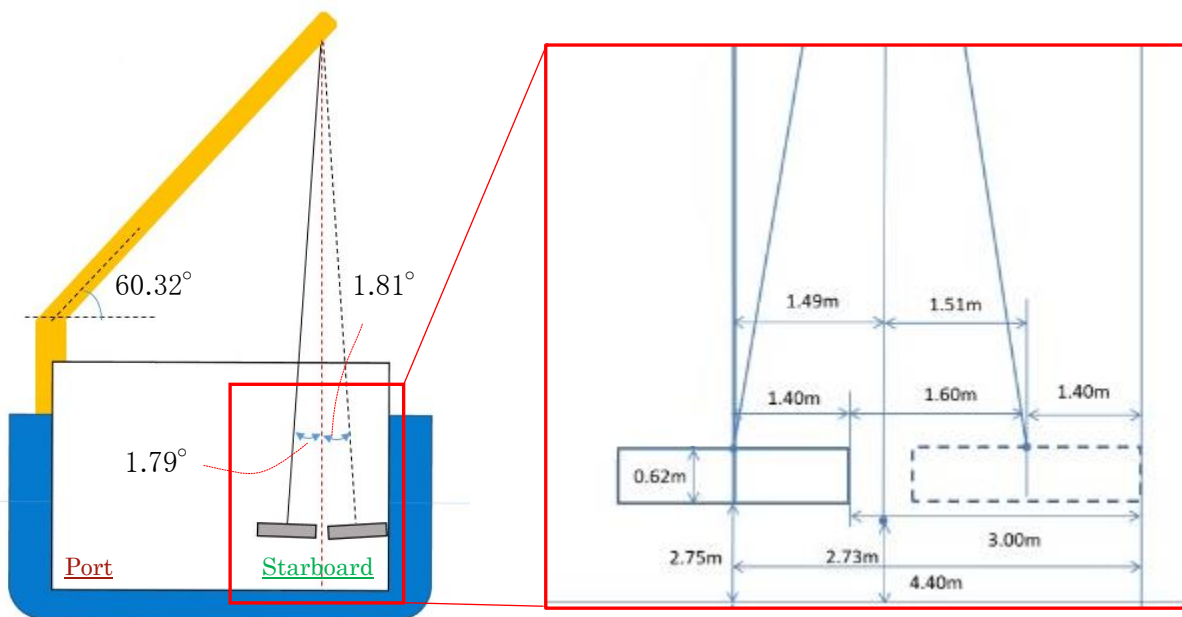
Figure 2.9-3 Positional relationship between the Pipes and the Starboard Wall

In the case of (2) 2) above, the Pipes were stopped at a position approximately three meters from the No. 2 cargo hold's starboard wall. Thus, the Pipes were in a state in which they would contact with the starboard wall on a pendular traveling path centered on the crane jib's end in the event of an approximately 1.81° inclination of the hull to the starboard side. (See Figure 2.9-3)

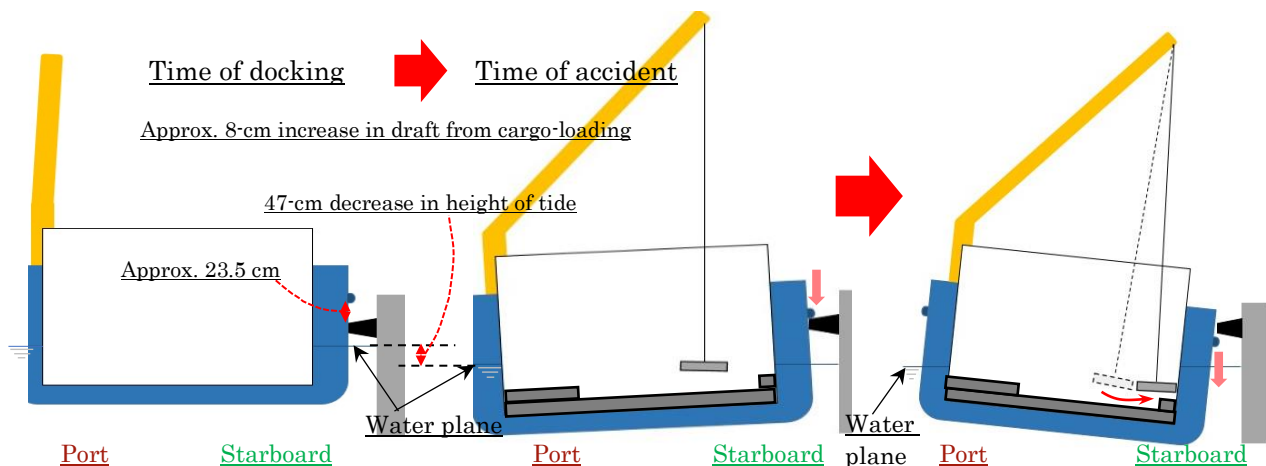
Figure 3-2 Circumstances of the Accident

- (3) Because, at the time of the accident, Vessel A's hull rolled and she inclined approximately 7° to the starboard side, the stopped Pipes swung in the starboard direction on a pendular traveling path centered on the crane jib's end and collided with the starboard wall of the No. 2 cargo hold. (See Figure 3.2)
