SIMPLIFIED SAFETY INVESTIGATION REPORT

REPORT NO.: 22/2017

MV THOMSON MAJESTY Engine-room fire South of Gorgona Island 21 October 2016

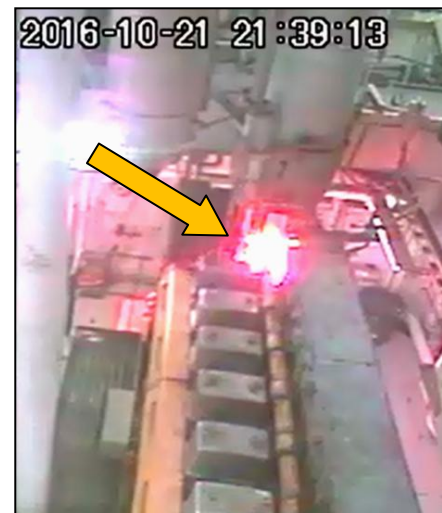
Minutes later, the OOW looked towards the CCTV monitors and observed smoke and flames from auxiliary engine no. 4 (Figure 1).

Figure 1: The start of the fire captured on CCTV

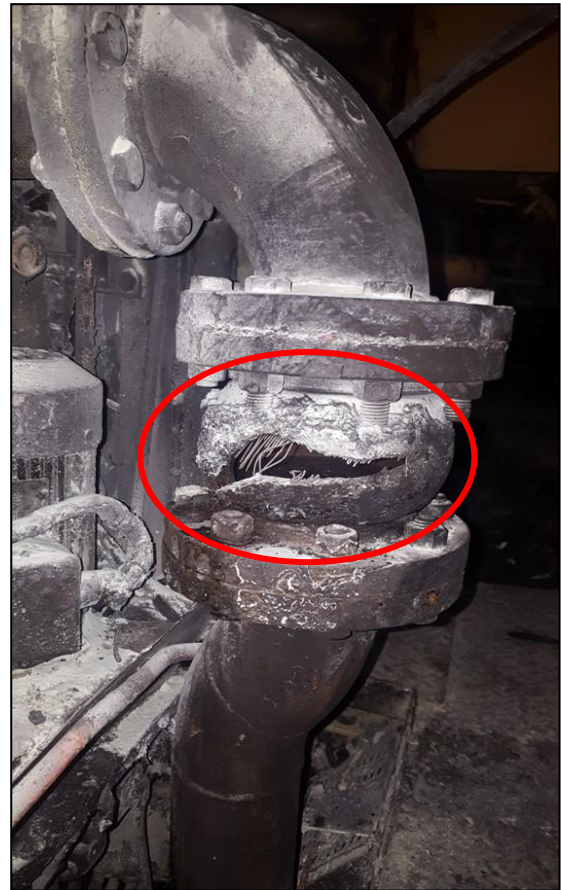
Due to the fire, the rubber bellows fitted on the cooling water line in way of auxiliary engine no. 4 was damaged and leaked heavily (Figure 3). Consequently, before the crew members could identify and rectify the problem, the cooling water expansions tanks leaked dry and the running auxiliary engines

shut down automatically due to the activation of the fresh water high temperature alarm at about 2200. The situation was, however, alleviated with the automatic starting of the emergency generator.

Figure 3: Damaged rubber bellows

Subsequently, the damaged bellows was replaced, the system replenished, and purged from air. Power was restored at about 0200 on 22 October 2016 and the vessel returned to Livorno with two auxiliary engines and two main engines running. No injuries had been reported.

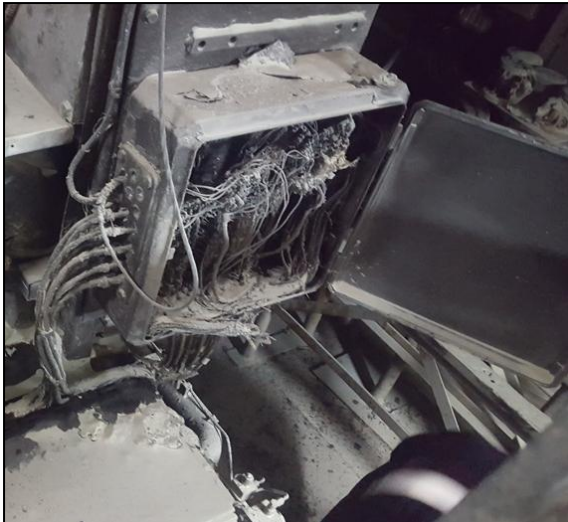
The damages were contained within the proximity of auxiliary engine no. 4. Electrical cables routed above the auxiliary engine and other control cables had to be cleaned and replaced where necessary (Figure 4).

Figure 4: Damaged control cables

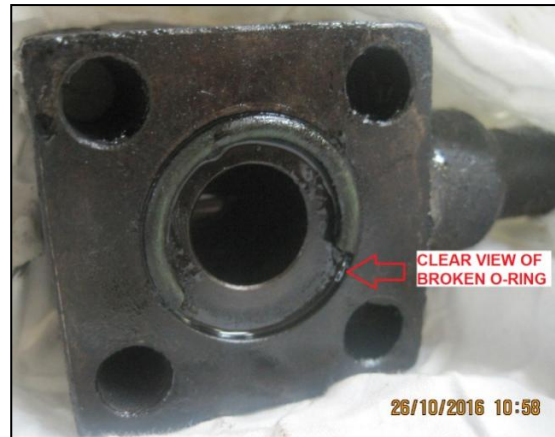
When the fuel oil return pipe was disconnected from the high pressure pump on unit no. 6, it was observed that the O-ring was damaged (Figure 5). The pipe was located very close to the turbocharger and the aft exhaust gas manifold. It was therefore confirmed that the fuel oil leak had originated from the fuel oil return pipe because of the damaged O-ring.

Figure 5: Damaged O-ring

It was also noticed that there were no records to confirm whether the O-Ring had been renewed before the system was boxed up again earlier during the day of the fire. Whereas it was not excluded that the (old) O-ring's physical and chemical characteristics had changed, it was also very possible that the O-ring got displaced before it was fitted and was permanently damaged when the flange was tightened. Consequently, there was no tight seal and eventually, fuel oil under pressure leaked from between the flanges and the spray. It was therefore evident that the system was either not tested after the repair job was completed or else, if tested, no leaks were detected.
