## SIMPLIFIED SAFETY INVESTIGATION REPORT

REPORT NO.: 20/2017

### MV GARIP BABA Serious injury while working aloft in the Ionian Sea 15 October 2016

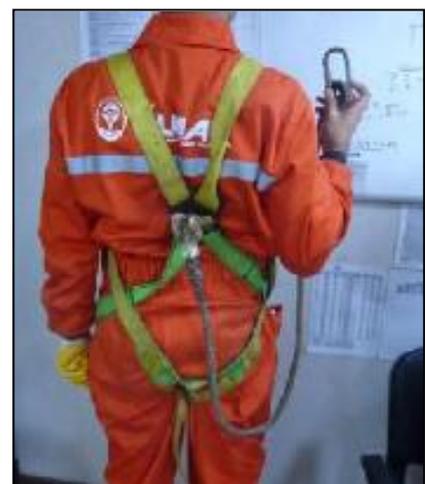
Figure 1: Safety harness similar to the one used by the bosun

The safety harness was a conventional one and inspections carried out soon after the accident revealed no problems or defects in the material. The harness, however, had one major design flaw. Given that there was one hook, it required the user to unhook it from the securing point before any significant movements could be made.

This was ironic, given that the probability of losing one's balance was precisely during the relocation and hence, when the safety harness was unsecured. This latent issue was not detected during the risk assessment process. Although the risk of fall whilst climbing up and down and during the work *per se* was mentioned in the risk assessment, this was only addressed by referring to the 'Work Aloft' Checklist. The Checklist, however, made no reference to the disconnection of the safety harness' hook and hence the risk remained unaddressed.

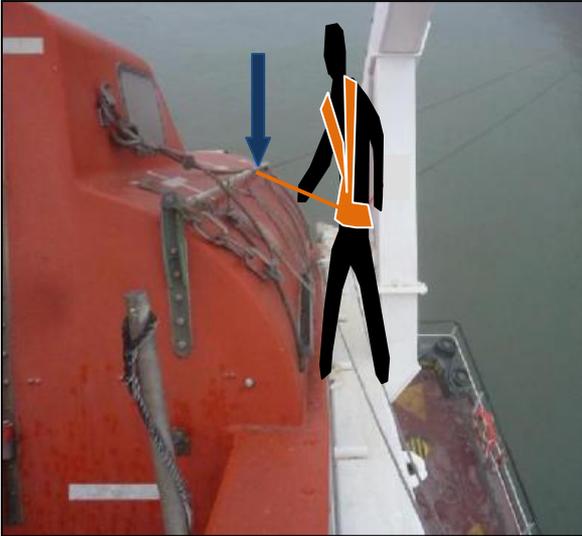
**Figure 2: Blue arrow shows where the safety harness was attached to the lifeboat's railing**

The bosun recalled that he was trying to relocate himself on the davits and therefore had to unhook the safety harness from the lifeboat's railings. It was during this particular moment that he lost his balance and consequently fell to the poop deck.

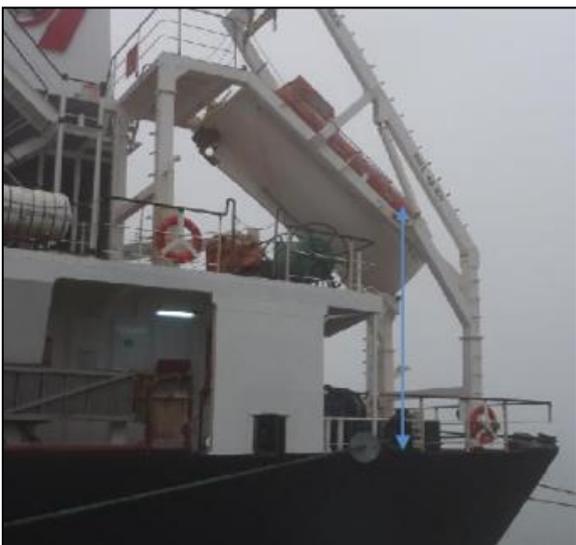
At one point in time, the bosun moved to relocate himself to a different position on the davits. During this process, he lost his balance and fell down from the davits to the poop deck, in close proximity of the mooring winches (Figure 3).

**Figure 3: The drop from the davits to the poop deck was about 4.0 m**

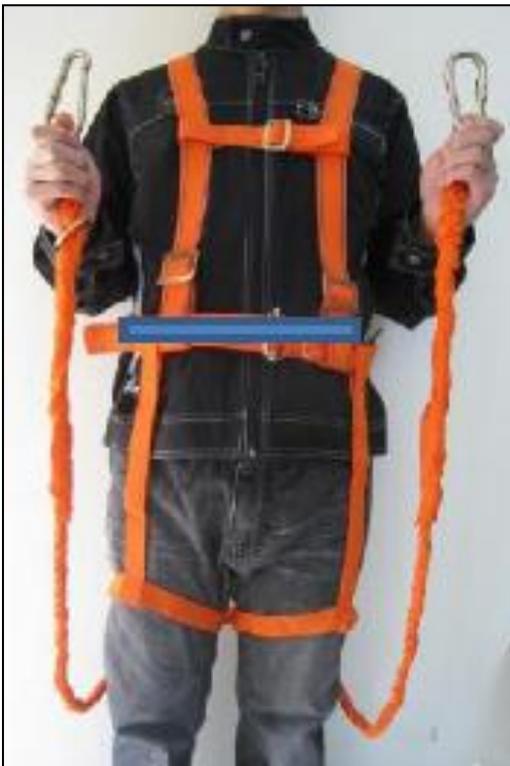
**Figure 4: Safety harness designed with two hooks**

Moreover, the Company has provided its vessels with safety harnesses that are fitted with two hooks (Figure 4).

This design will ensure that at any point in time, one hook is always attached to a secure point, even during necessary repositioning of the crew member.
