MARINE SAFETY INVESTIGATION REPORT

Safety investigation into a fatality of a crew member on board the Maltese registered container ship

SYDNEY TRADER

Off Port Limits Anchorage, Hong Kong on 02 September 2016

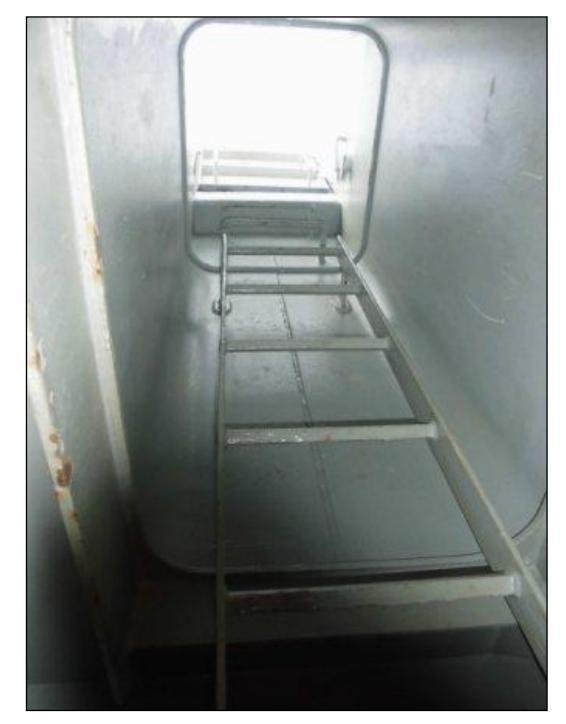
Figure 1: Access to cargo hold no. 2

An inspection of the cargo hold was carried out during the course of the safety investigation. The access manhole to cargo hold no. 2 (Figure 1) was positioned aft in way of Bay 19, Row 04, hatch port no. 2 M, above the port middle cross section.

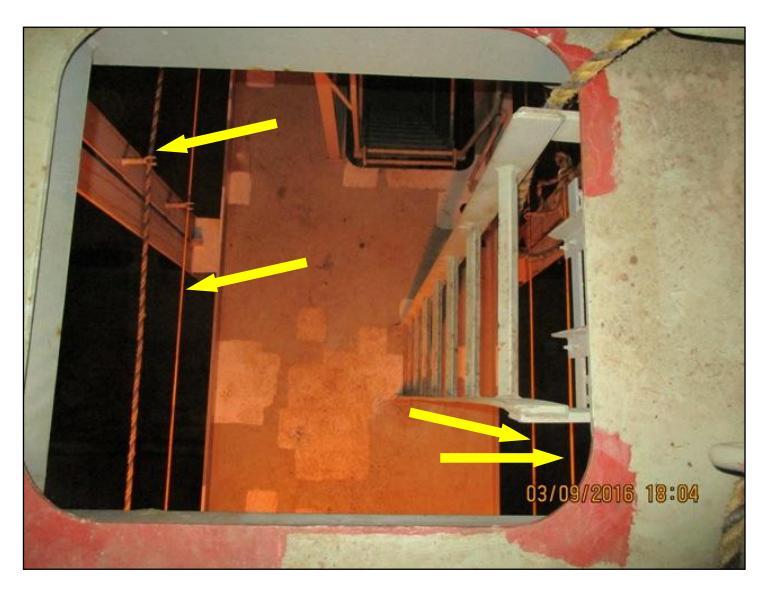
Figure 2: Vertical ladder to second platform from platform no. 1, showing the position of the safety wires

The access was possible via two vertical ladders, each approximately 2.5 m in length, to platform no. 2 on the middle cross section (Figure 2).

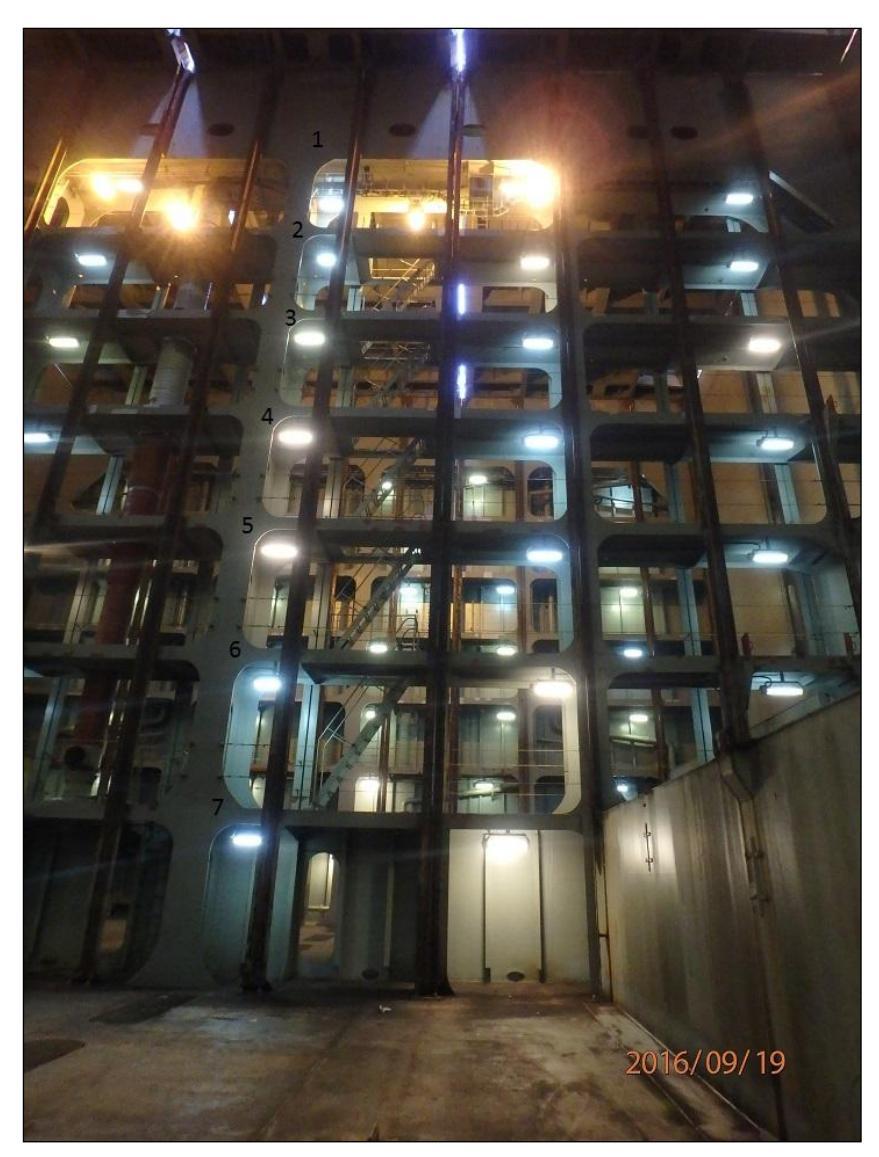
Figure 3: Position of the platforms inside the cargo hold

The port middle cross section consisted of seven platforms (Figure 3). Platforms nos. 3 to 7 were accessible via a stairway. Access to the cargo hold tank top from platform no. 7 was via a vertical ladder, approximately 2.5 m long.

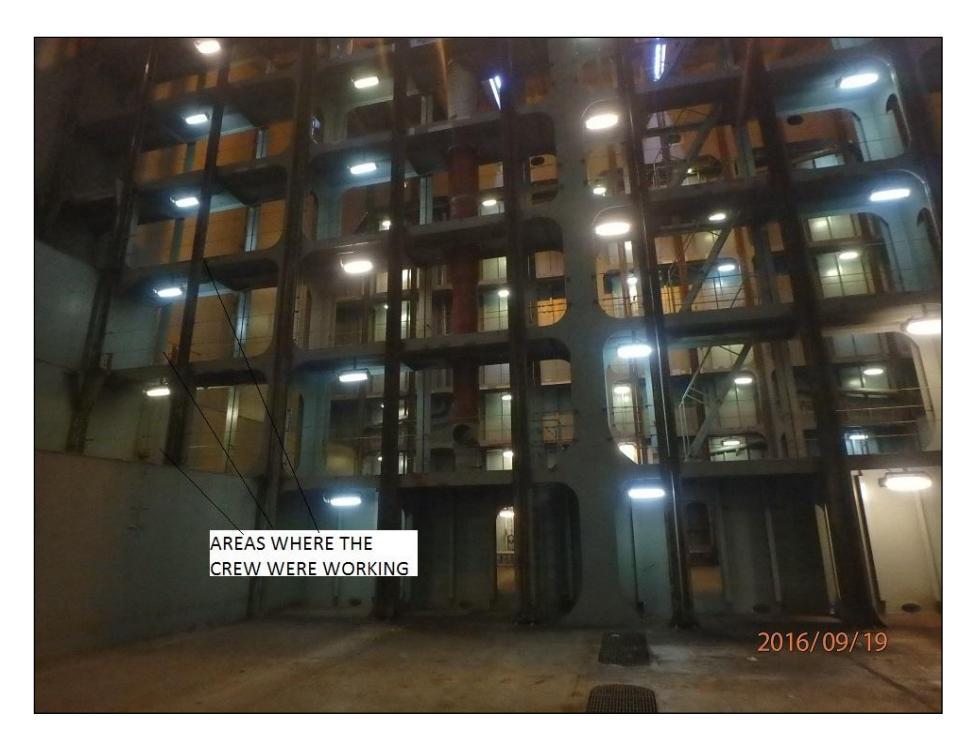
Figure 4: Areas where the crew members were working when the accident happened

The crew were assigned areas to chip and paint at the aft end of the lower middle cross section platforms (Figure 4). While working on the platforms, it was neither possible to view platform no. 2 nor the vertical ladder on the platform.

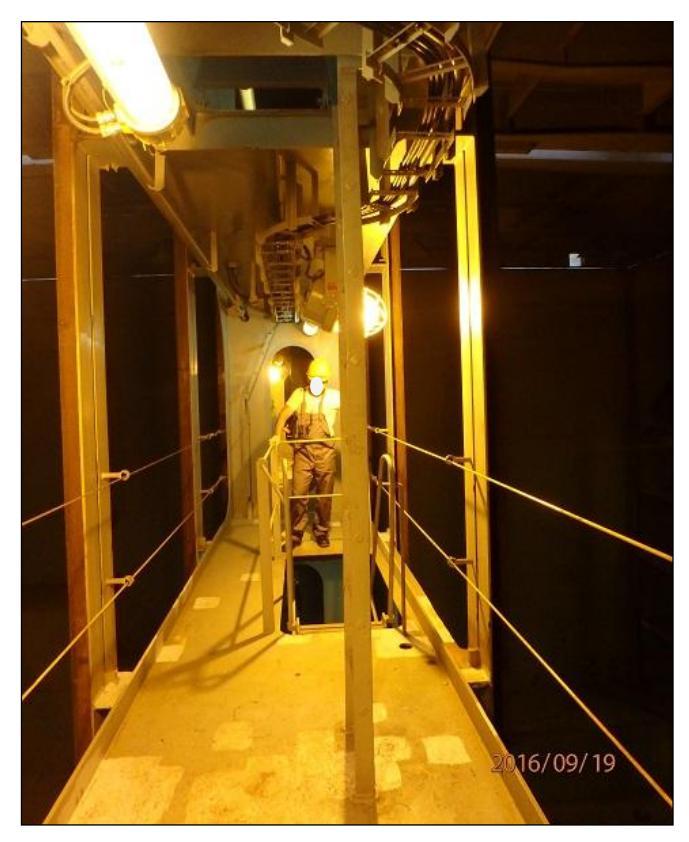
Figure 5: Position of the vertical ladder on platform no. 2 and the safety wires on either side

Two steel safety wire guards (lower & upper) were fitted on either side of each of the platforms to prevent personnel falling into the cargo hold (Figure 5). A yellow plastic sleeve was fitted around the entire length of the safety wires.

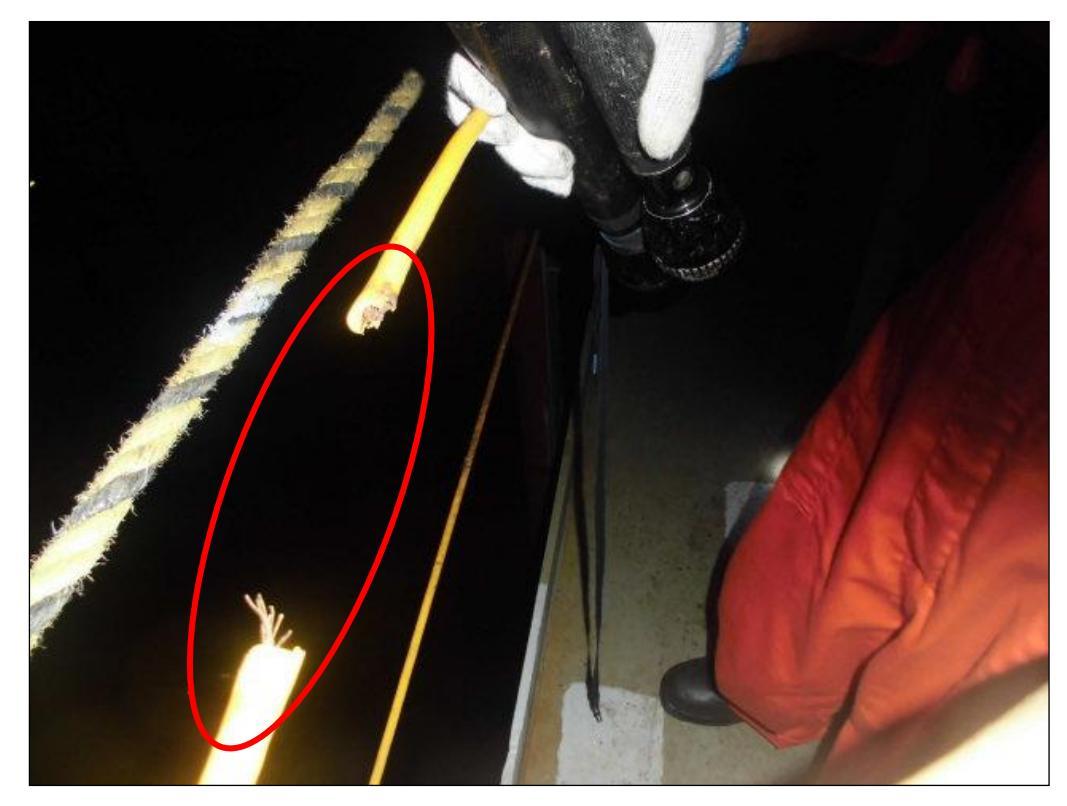
Figure 6: Both ends of the parted safety wire

Soon after the accident, several members of the crew noticed that the upper guard safety wire was broken (Figure 6), close to the end frame from where it had been secured. The safety wire was positioned on the inboard side of platform no. 2, (Bay 19, row 03, tier 14), above the area where the casualty's body was found on the tank top.

It appeared that the OS may have leaned on the safety wire, possibly putting his full weight on it to look down to the cargo hold tank top, causing the safety wire to fail. It was also deemed possibly that he tripped or lost his footing after descending the ladder and grabbed the safety wire to steady himself, causing the safety wire to fail. He then lost his balance and fell down into the cargo hold.

a weakened safety wire due to severe corrosion of the strands, possible due to the daily exposure to and penetration of natural elements; and 2. the actual fall of the OS from an unknown height on the safety wire (or full body weight leaning against the safety wire).

- 19/2017_R1 replace all safety wires, considering that these safety barrier systems
 are an intrinsic part of the on board safety;
- 19/2017_R2 apply a definite life-cycle to the safety wires and address this in the vessel's safety management system and the related planned maintenance regime to ensure that all safety wires inside the cargo holds are replaced at regular intervals.

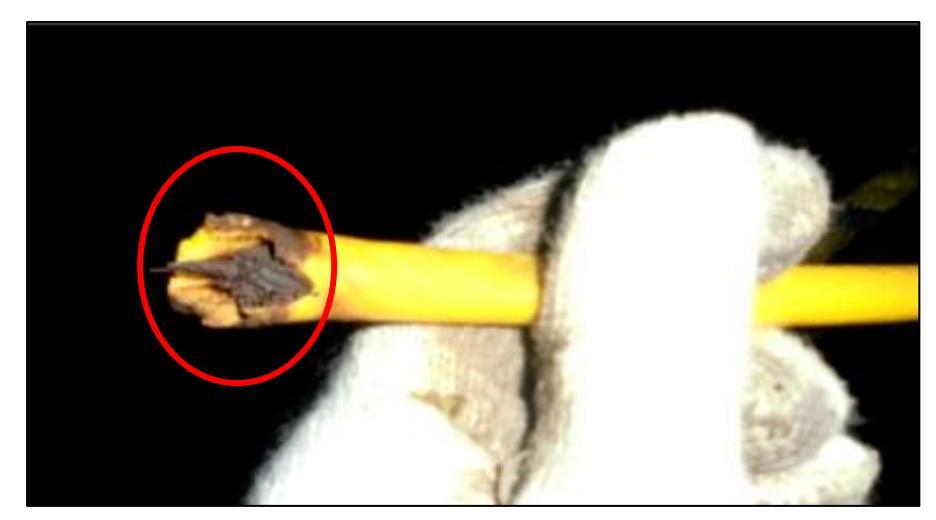
Figure 7: Corroded safety wire inside the yellow sleeve

The photographs provided by the vessel showed that the safety wire strands were corroded (Figure 7). However, a close inspection of the safety wire revealed that it would not have been possible to observe the condition of the safety wire, given that it was sheathed within the yellow plastic sleeve, although there were rust marks on the surface of the sleeve, indicating that this area of the safety wire had been corroding.

The MSIU did not have information on whether the safety wires had been ever load tested or visually inspected on regular basis, perhaps as part of the vessel's planned maintenance system. It was understood, however, that the safety wires had been in place since 2005, when the vessel had been delivered.

The MSIU was unable to determine whether the safety wire would have been able to withstand the force generated by a falling person, had it been in a new condition. Nonetheless, it is plausible to hypothesis that the corroded safety wire strands would have reduced the overall tensile strength of the safety wire.

The fact that the safety wire was sheathed and considering its location inside the cargo hold, this made it susceptible not to be inspected and replaced. Although there were traces of rust across the outside circumference of the safety wire sheath, it would have been virtually impossible for the crew members to determine the extent of the (internal) corrosion damage within the safety wire strands.

It was ironic that the very same sheathing which was fitted to protect the safety wire had actually served to conceal a lethal problem, which led to the ultimate failure of the safety wire.
