Report on the investigation of the grounding of

Transocean Winner

following the loss of tow from

8 August 2016

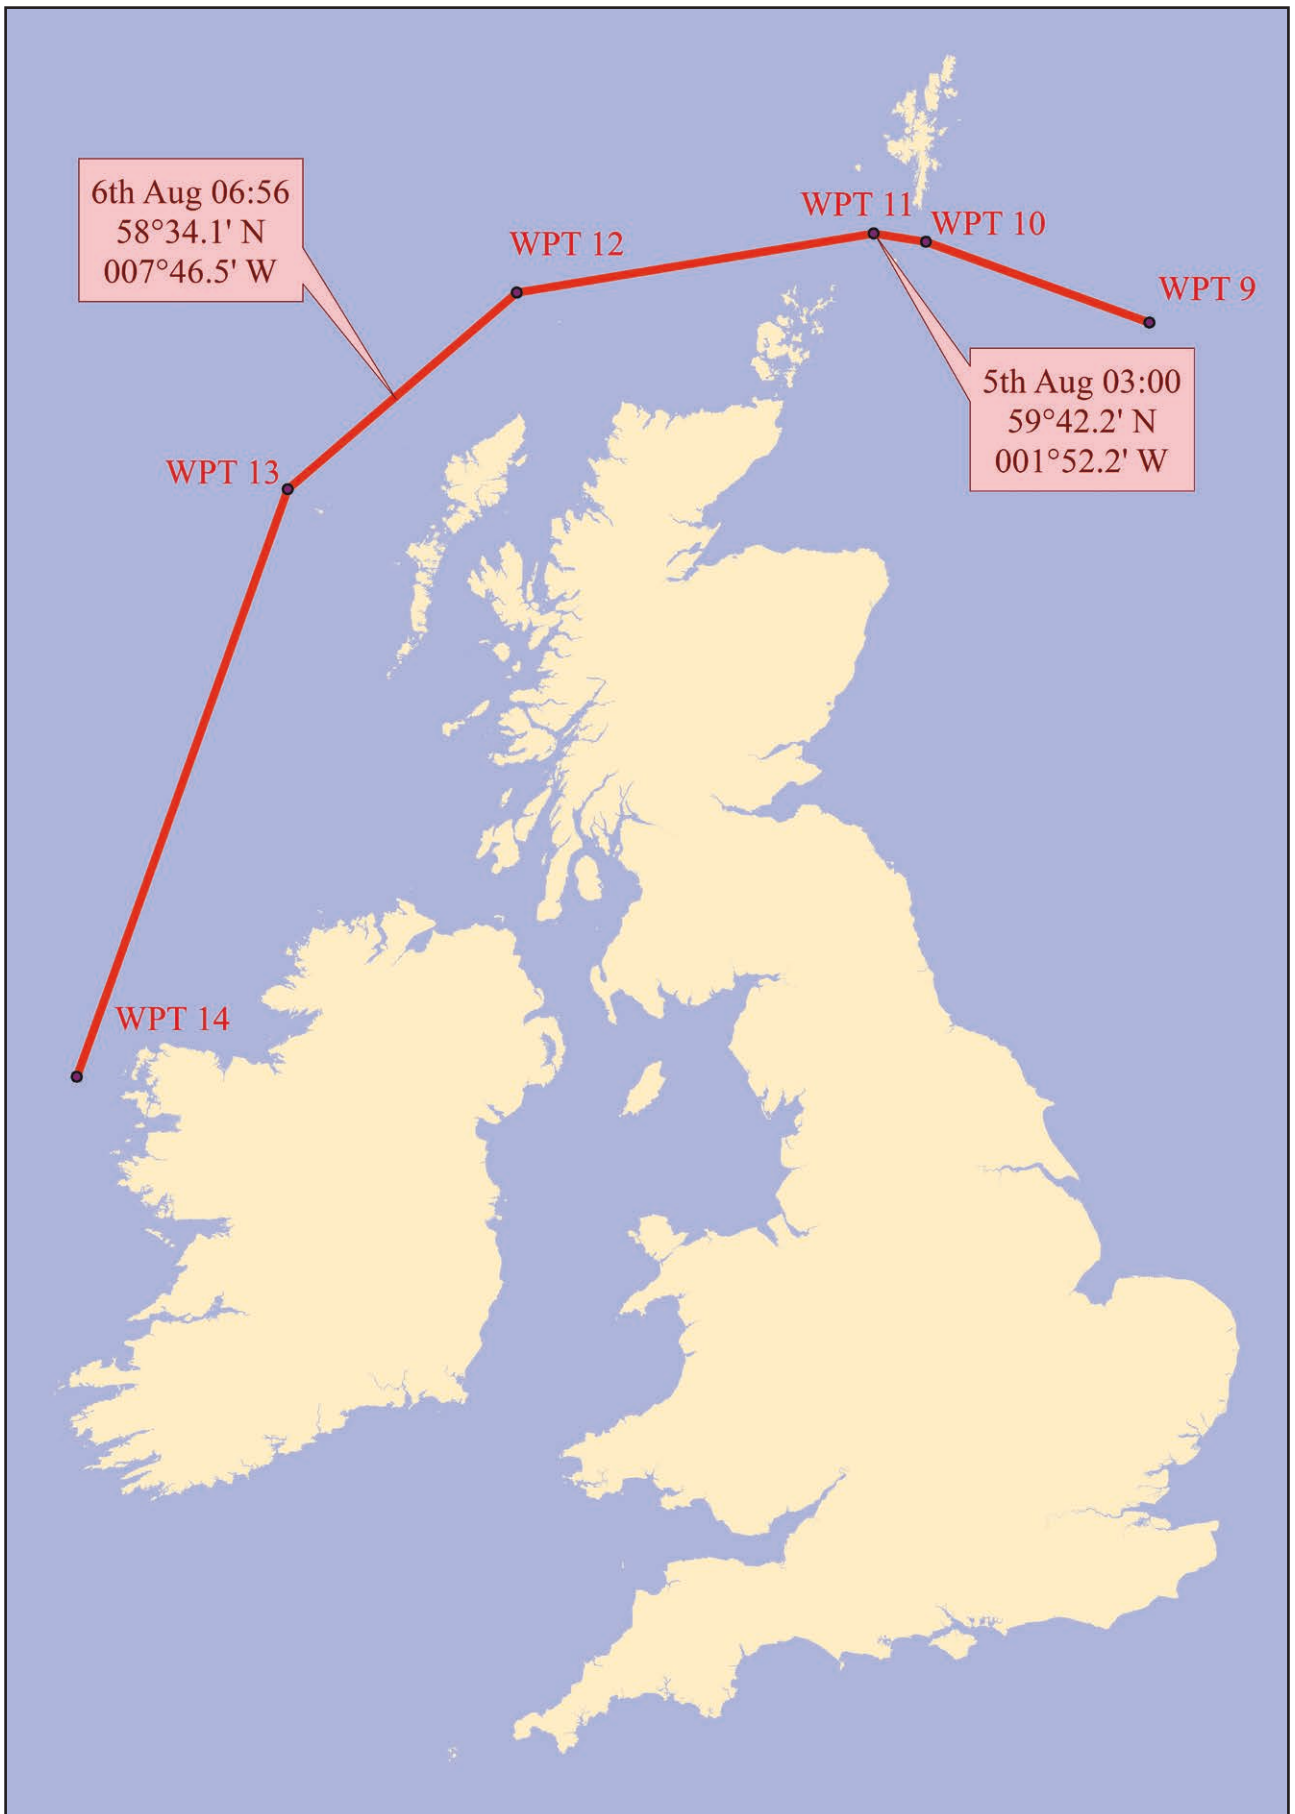
Figure 2: Planned route around Scotland

The tug and tow progressed as expected and, at 0300 on Friday 5 August, reached waypoint 11 on its passage plan, south of the Shetland Islands (**Figure 2**). *ALP Forward* then altered course to follow the passage plan, which would take the tug and tow north of the Orkney Islands, to the north-west of the Flannan Isles and west of Saint Kilda before running down the west coast of Ireland and on to the Bay of Biscay.

and west of Ireland. The tug and tow would then head south to transit the Bay of Biscay before entering the Mediterranean towards its destination of Malta. The near coastal sections of the route were planned to be at least 12nm off the coast as the master wanted to keep outside territorial¹⁴ waters, to maintain sea room and avoid recreational traffic (**Figure 2**).

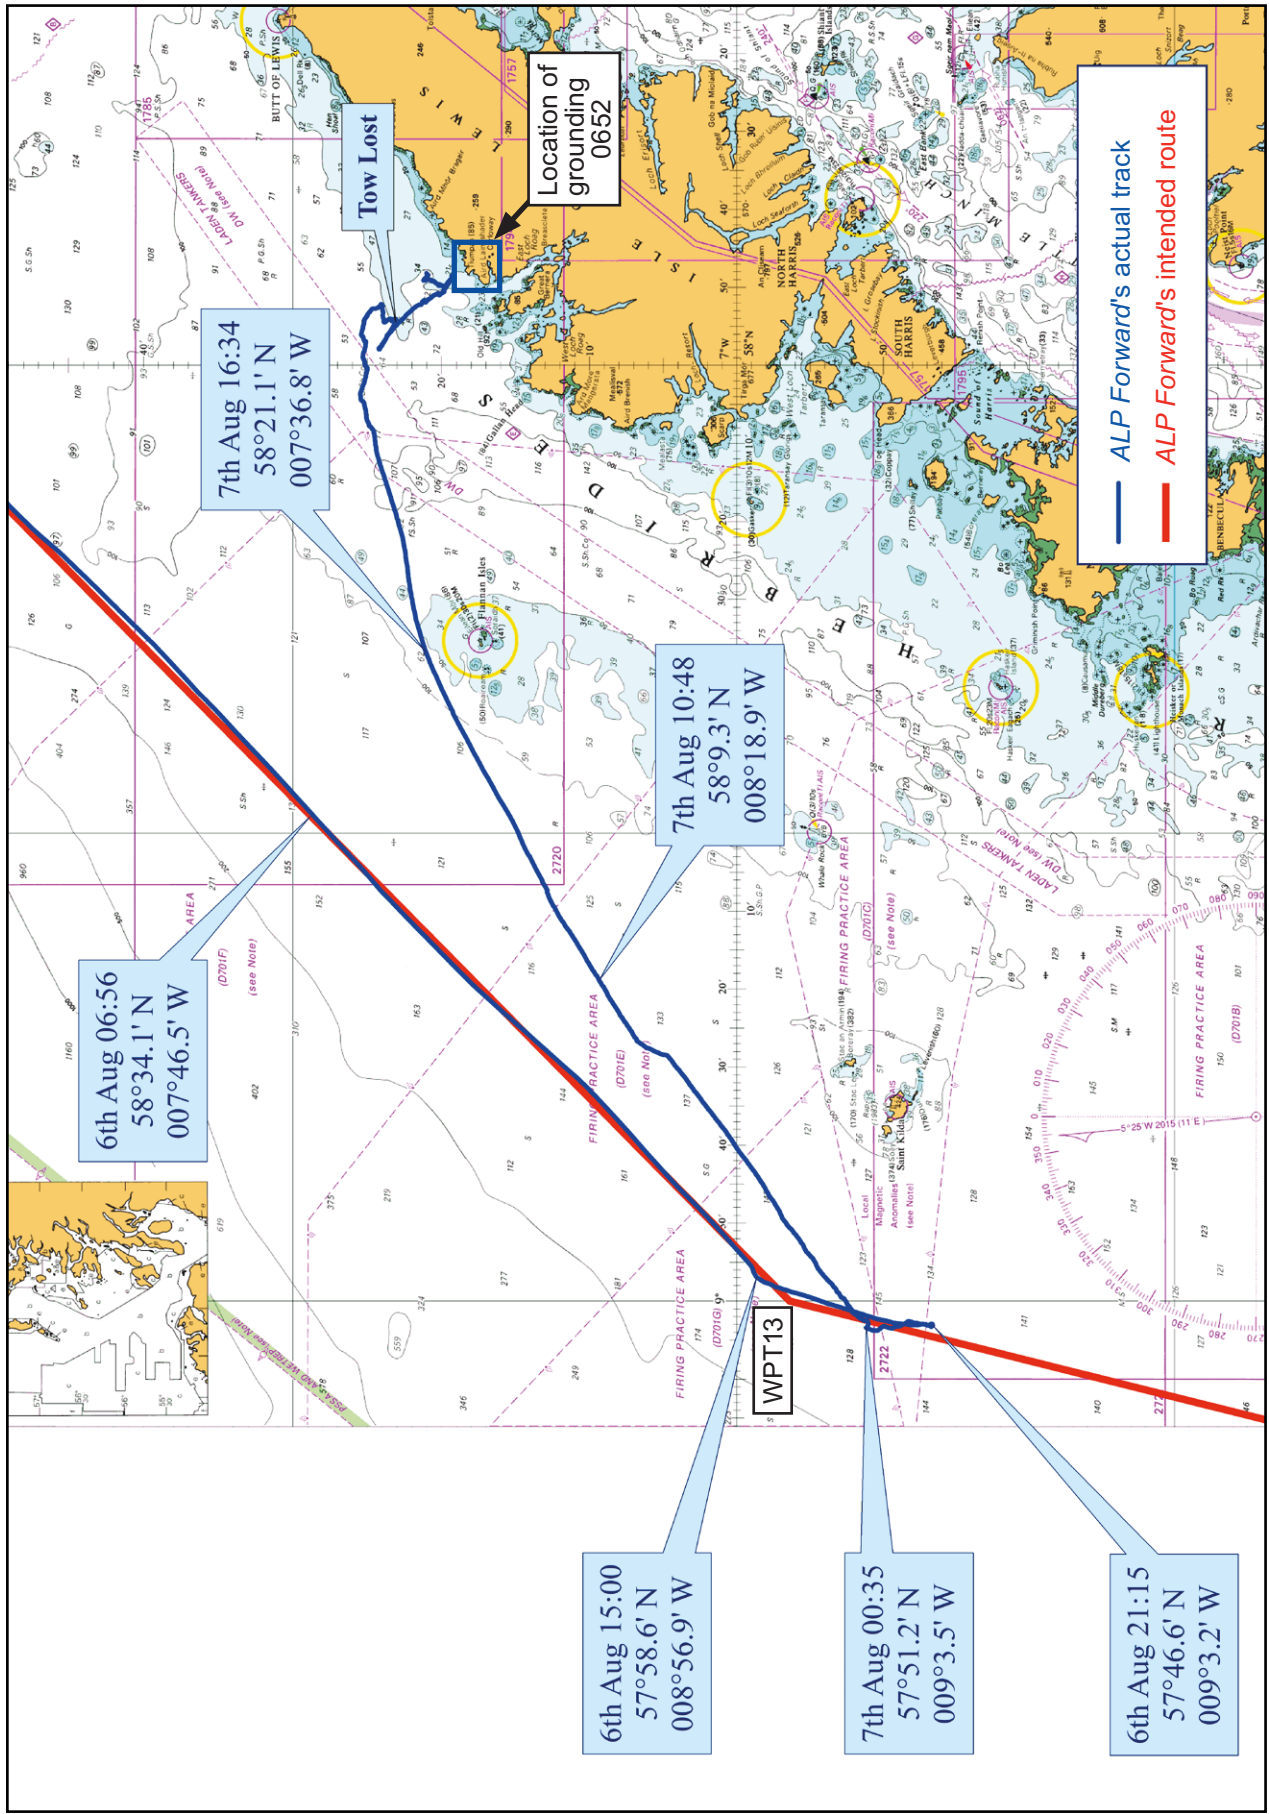
Figure 3: ALP Forward's track and positions 6 – 8 August

On Saturday 6 August, at approximately 0656, the tug and tow passed abeam of the Flannan Isles on course 227° (heading of 229°), with a SOG of 7.5kts (**Figure 3**). The wind was south-easterly at 12kts and the forecast was for it to strengthen to a severe gale that evening with gusts of 42kts (**Annex A**). By 1200 the low pressure in the North Atlantic Ocean had deepened and the sea and wind conditions had deteriorated with gusts of up to 35kts, reducing the SOG of the tug and tow to 5.7kts.

Throughout the afternoon and into the early evening, the tug's speed decreased as the weather worsened. By 2115 the forces exerted on the tow line by *Transocean Winner*, under the influence of the wind and the seas, overcame the 120t tension limit set by the master and the tug began to be dragged backwards on a meandering northerly track (**Figure 3**).

The tug and tow were taken north until 0035 on Sunday 7 August when the wind veered to the south-west and they began to track north-east, almost parallel with the Scottish coastline (**Figure 3**).

At 1634 the tug and tow passed approximately 3.7nm north-west of the Flannan Isles. The wind then veered to the north-west and increased in strength again to gale force, pushing them towards the Isle of Lewis with a SOG that peaked at 4.7kts (**Figure 3**).

At 0536, *ALP Forward's* master informed the coastguard that he was unable to establish the emergency tow but would monitor the rig's progress. At 0652 *Transocean Winner* grounded on the north coast of the Isle of Lewis (**Figure 3**).

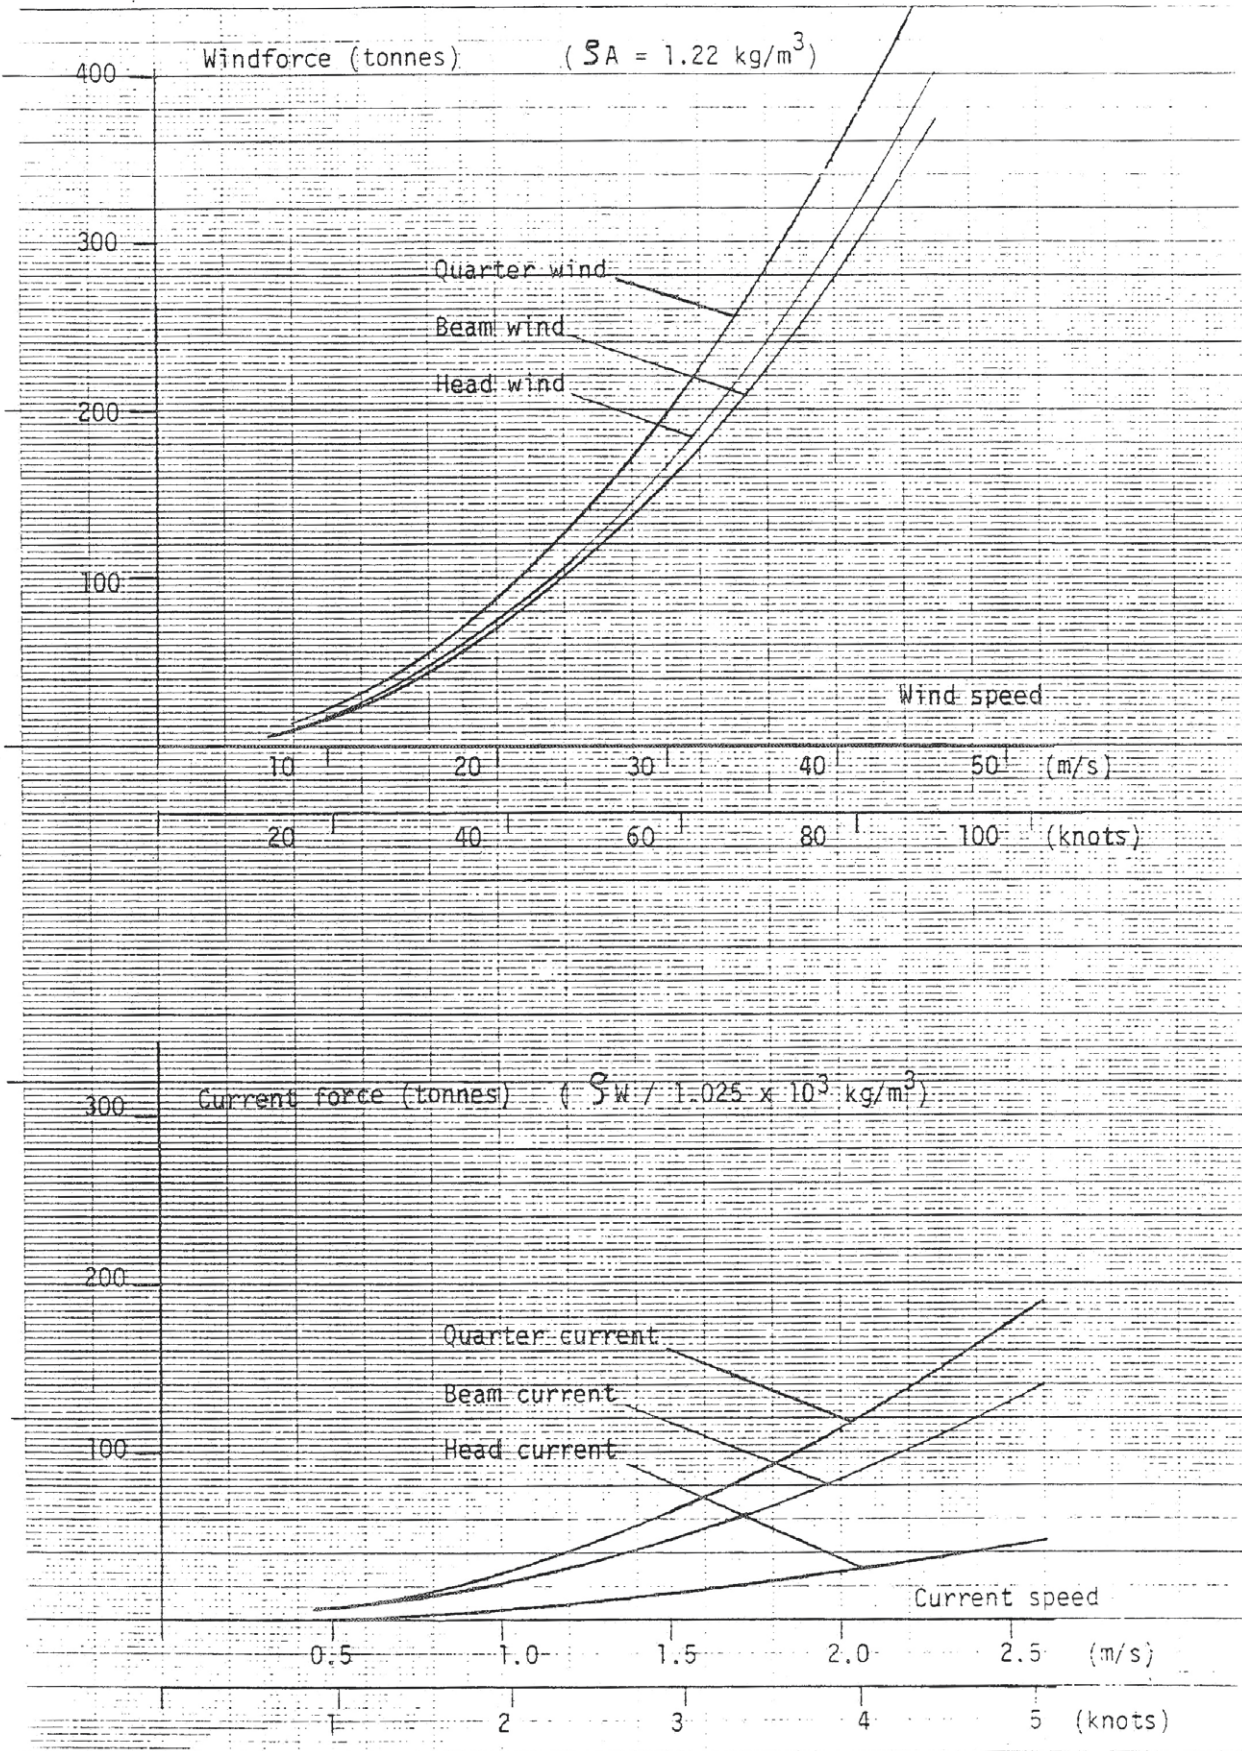
Figure 7: Wind and current forces for draught of 10.98m

Aqualis recorded that *Transocean Winner* had been ballasted to a draught of 9.85m forward and 10.25m aft. No subsequent changes were recorded and, given that the rig's anchors had already been removed, it is considered unlikely that the rig's draught would have changed significantly prior to departure. This was consistent with the 7.22m transit draught without thrusters (which added approximately 2.3m) that was stated in the Marine Operation Manual, though slightly less than the 10.98m draught stated for the wind and current forces diagram (**Figure 7**).

The Towing Manual did not contain any windage information and this had been neither requested by, nor supplied to ALP. The windage graph from *Transocean Winner's* Marine Operations Manual for a transit draught of 10.98m (**Figure 7**) shows that a headwind of 56kts, the approximate strength of the forecast winds, would be sufficient to overcome the 120t tension limit the master applied to the tow line (in practice, a lower wind speed was needed since the draught was less). Despite the master's recognition that the weather was worsening, and the concerns raised by ALP's operations manager in his telephone call of 4 August, ignorance of the rig's windage and the effect it would have had, led the master to remain confident that the tug and tow would be able to pass ahead of the worst weather conditions.

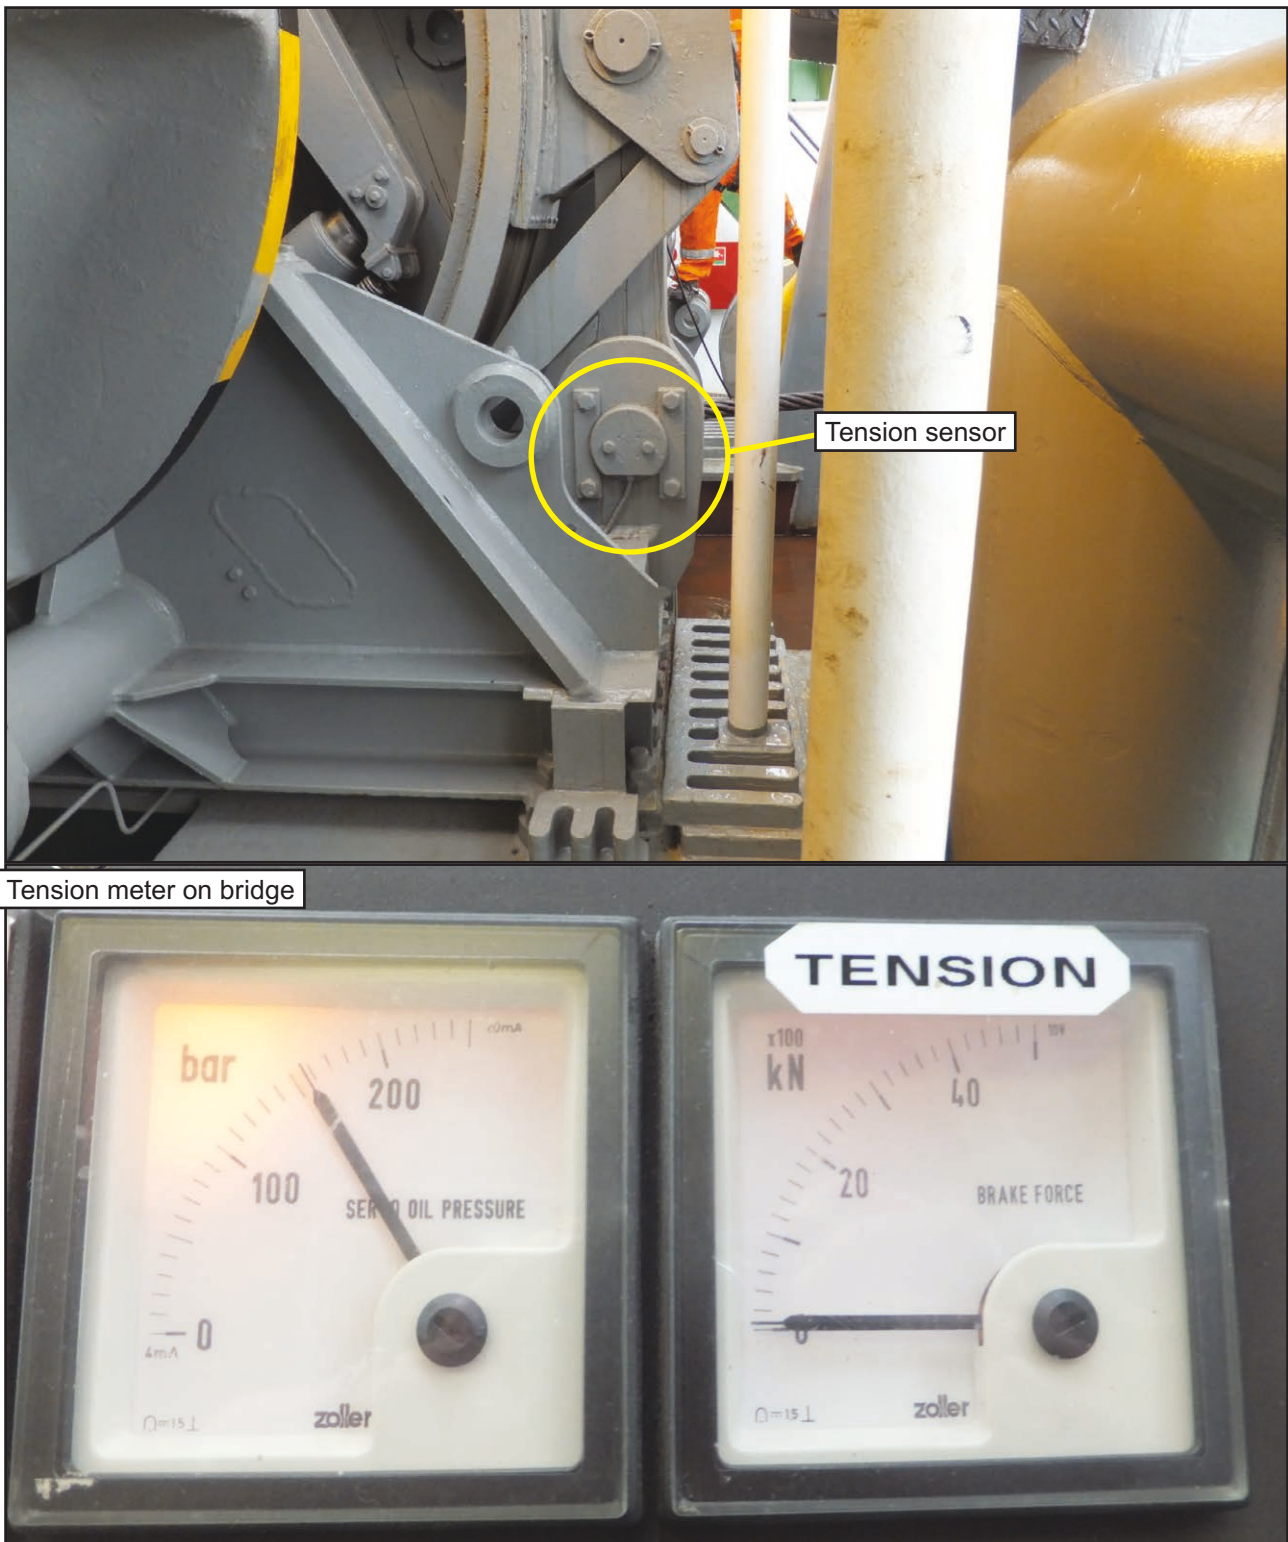
Figure 8: Tension sensor and wheelhouse tension meter

On the main deck, the electric main towing winch was capable of hauling 300t at 5m/minute. The winch was fitted with a tension sensor (**Figure 8**) with a local display and a repeater in the wheelhouse. Also located on the main deck were two drums holding the main and spare tow lines. Each tow line was 76mm diameter 'Super Titan' steel wire rope, which were 1600m and 1200m long respectively.

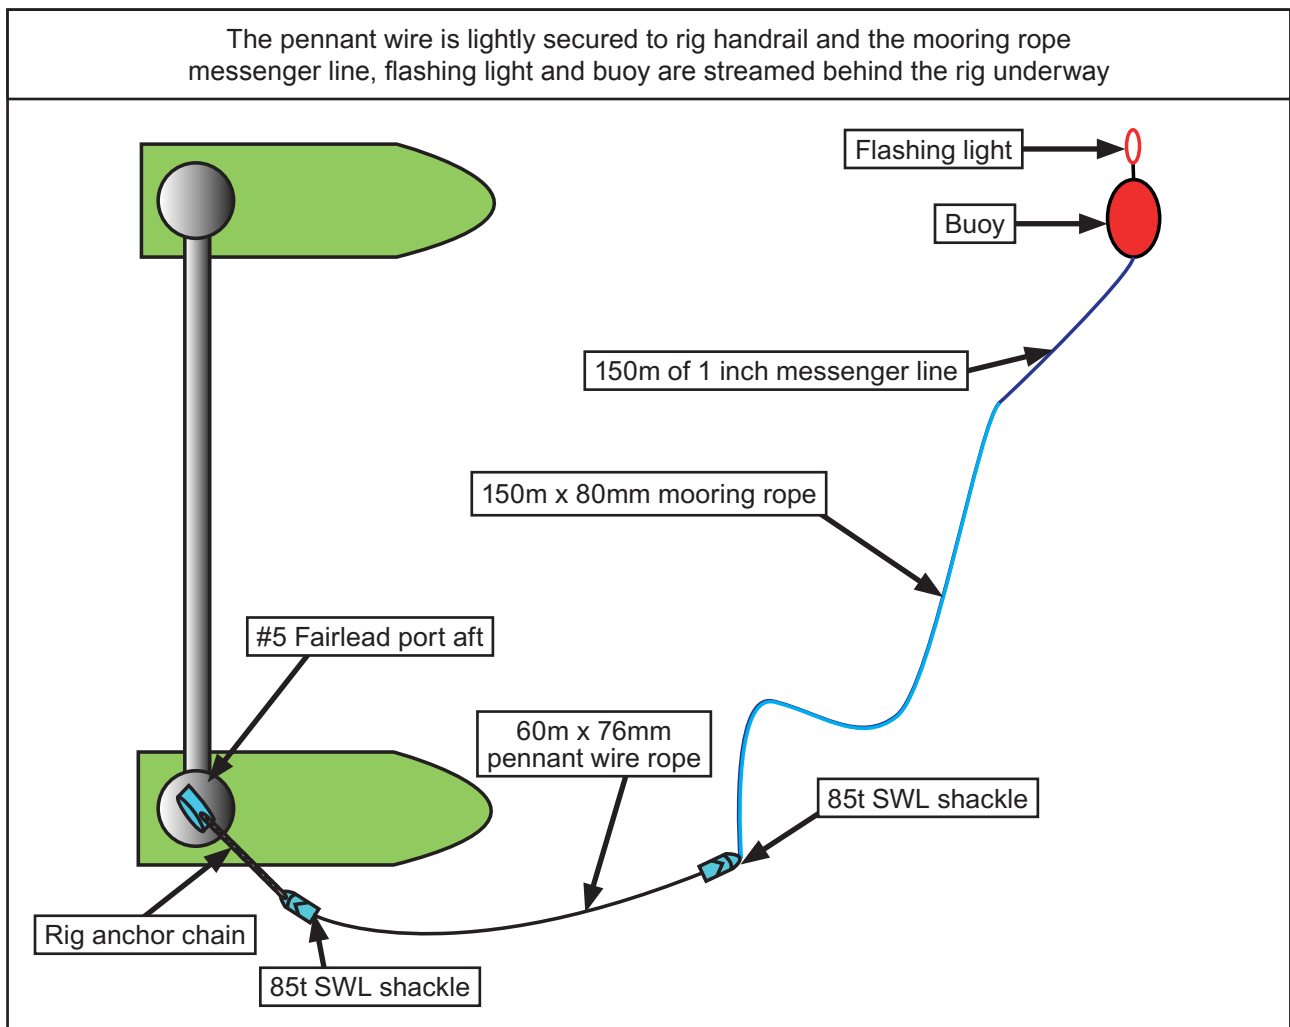
Figure 12: *Transocean Winner* emergency tow arrangement port aft

The emergency towing arrangement (**Figure 12**) for *Transocean Winner* was rigged as specified in the Towing Manual as required by MSC/Circ 884 and 0030/ND, and in accordance with Transocean's Marine Operations Manual. It consisted of 60m of 76mm 450t minimum breaking load wire rope attached to the port pontoon's aft anchor chain. This wire rope was secured to the rig's handrails by weak links, such that it would break free of the handrails under tension without the need for personnel to board the rig. The end of the wire rope was secured to 150m of 80mm buoyant mooring line, which connected to the 150m of 25mm messenger line. To help the tug's crew locate the messenger line a wave rider buoy with a flashing light was connected to its free end.
