MA2017-9

**MARINE ACCIDENT
INVESTIGATION REPORT**

Vessel type and name: Cargo Ship BBC ASIA

Accident type: Death and injury of workers

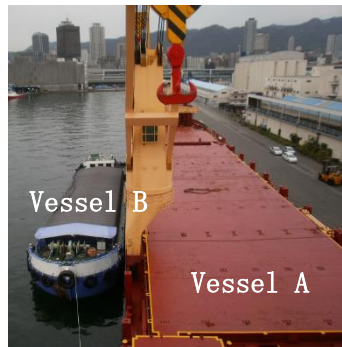
Photo 2.1-2 Circumstances of Vessel B Alongside Vessel A (After the Accident)

At around 8:30, Barge SK1001 (hereinafter referred to as “Vessel B”) loaded with the Bundled Pipes that were scheduled to be loaded onto Vessel A berthed port-side alongside on Vessel A’s port side. (See Photo 2.1-2)

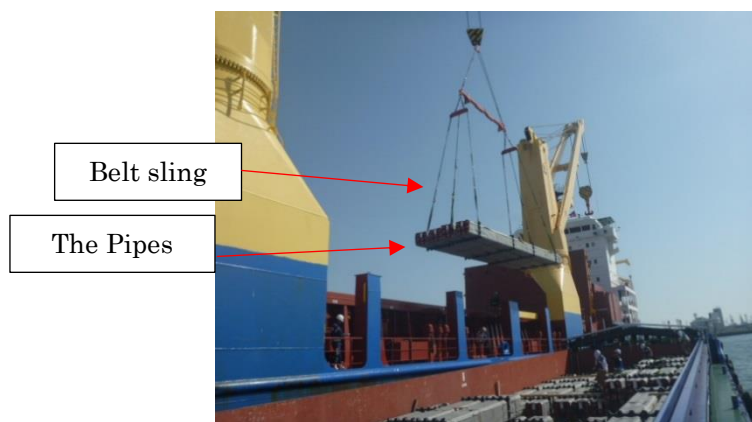
Photo 2.1-3 The Pipes Hoisted from Vessel B
(Courtesy of the Nippon Kaiji Kentei Kyokai)

The Winchman, operating the No. 1 crane in accordance with signs he received by transceiver from the Deckman, moved “four bundles of nine-piece Bundled Pipes that he hoisted from Vessel B” (hereinafter referred to as “the Pipes”) toward the center of the No. 2 cargo hold. (See Photo 2.1-3)

When he saw the Pipes above the port side of the No. 2 cargo hold, the Signal Man had the Pipes moved toward “the port side of the Two Bundles, which was the planned stowage position” (hereinafter referred to as “the Stowage Position”) by instructing the Winchman by transceiver to rotate the crane jib and lower the wire rope.

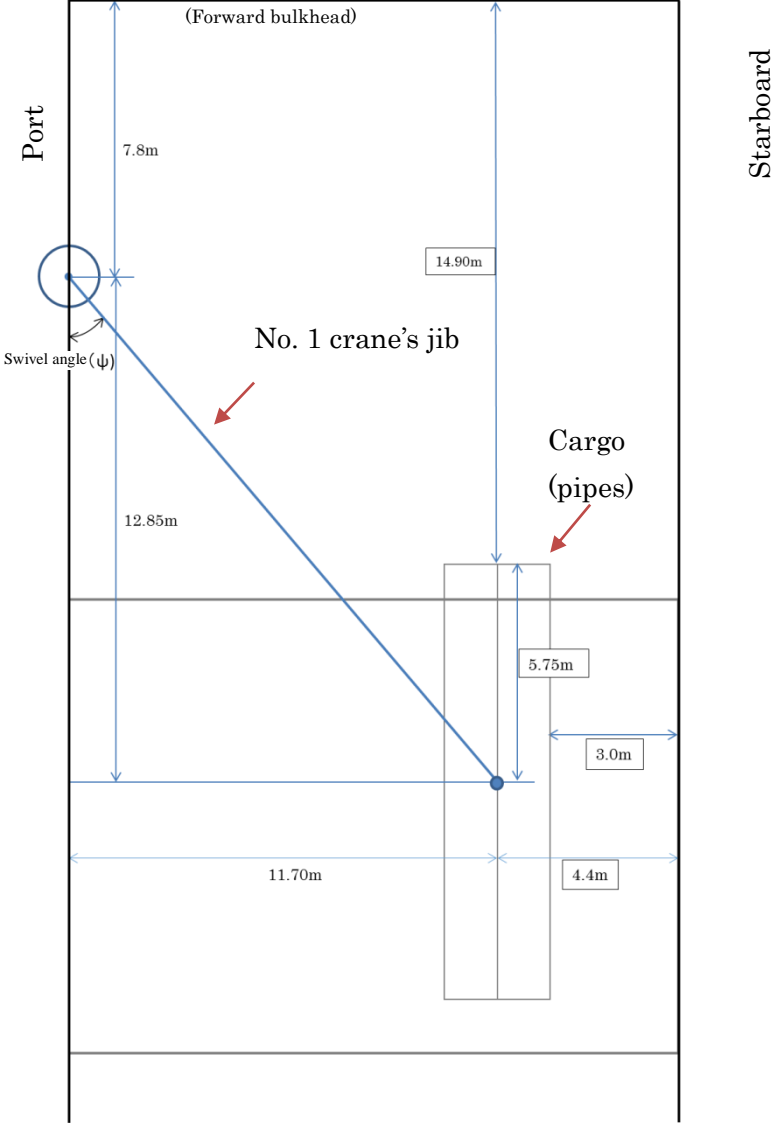
Figure 1: Positional Relationship (1) between the Hoisted Cargo and No. 1 Crane (No. 2 Cargo Hold Plan)

It should be noted that the suspended position of the cargo prior to the accident that is identified in the investigation (hereinafter referred to as the "Established Position") is 2.75 meters from the floor of the No. 2 cargo hold to the bottom surface of the cargo; 4.40 meters from the starboard wall of the cargo hold to the center of the cargo and 3.00 meters to the starboard side of the cargo; and 14.90 meters from the forward bulkhead of the cargo hold to the forward side of the cargo (see Figure 1).

Now we obtain the jib angle of elevation φ and swivel angle ψ (from the aft direction) using values found in materials provided by the Japan Transport Safety Board (hereinafter referred to as the "Materials"). The length of the jib is 37.185 (meters). At the time of the accident, a small hook (weight: 1.03 tons) was being used at the end of the jib. Therefore, the

positional relationship between the hoisted cargo in the No. 2 cargo hold and the No. 1 crane becomes that shown in Figure 1.

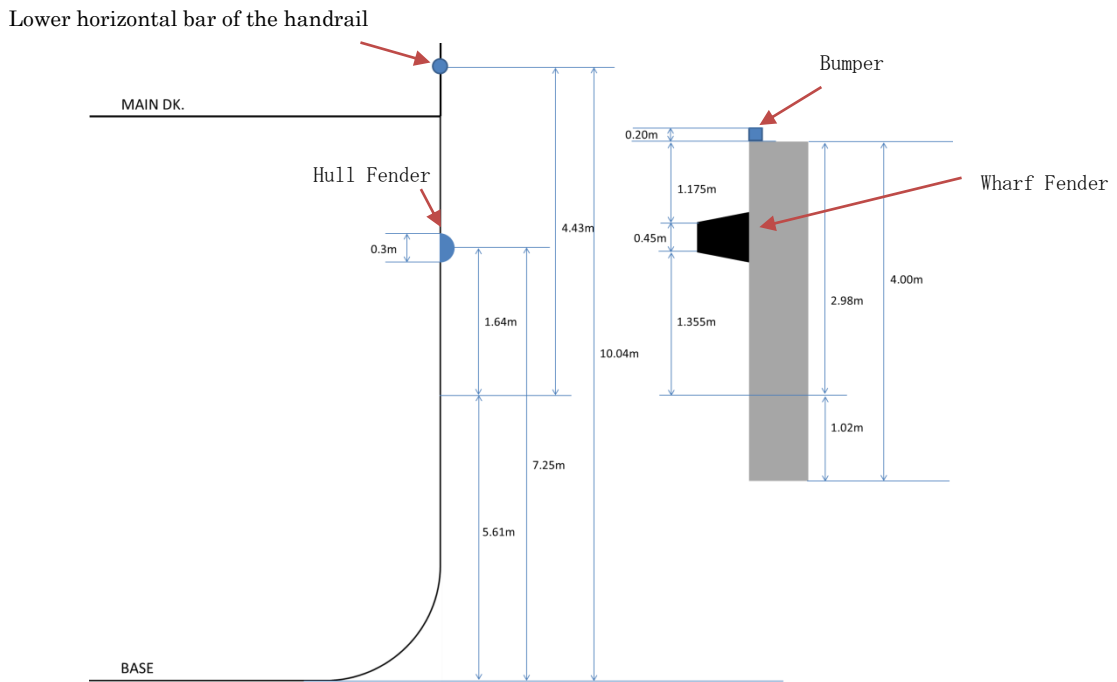
Figure 2 Positional Relationship between the Hull and the Wharf

At around 13:00 on November 1, with a height of tide (end of outgoing tide) and draft equivalent to those at the time of the accident, the underside of Vessel A's starboard-side Hull Fender contacted with and became caught on the tops of three fenders on the Wharf at approximately 30 meters, 49.6 meters, and 69.4 meters from Vessel A's stern end toward the bow. When the underside of the Hull Fender came off the tops of the wharf fenders, Vessel A's hull inclined toward the starboard side and rolled several times. Additionally, rust from the underside of Vessel A's Hull Fender was on the tops of the fenders on the Wharf. (See Photo 2.5-2)

From the Materials, the positional relationship between the hull and the wharf becomes that shown in Figure 2.

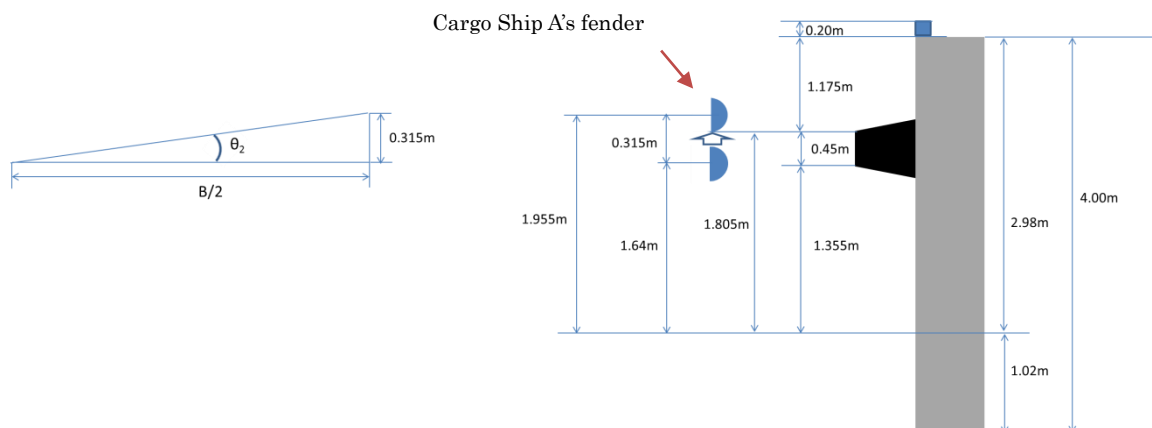
Figure 3 Upward Change in Position of the Hull Fender

As is shown in Figure 3, from the Materials, the rise of the hull's fender (change in position from the state in which the fenders are not caught) is 0.315 (meters). Accordingly, if the beam is expressed as B, θ_2 as a small angle is

$$\tan \theta_2 = 0.315 / (B/2) = 0.0312$$

$$\theta_2 = 1.79(\text{deg})$$

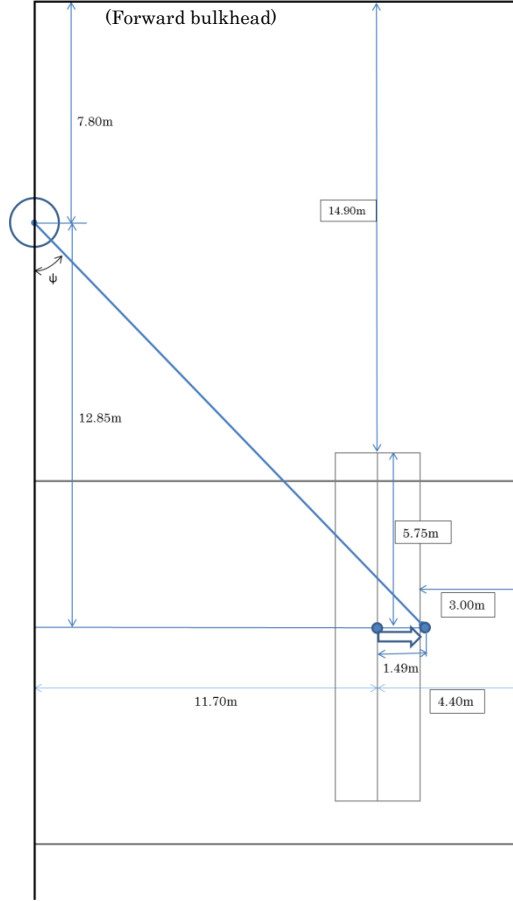
Figure 4: Positional Relationship (2) between the Hoisted Cargo and No. 1 Crane (No. 2 Cargo Hold Plan)

When the hull inclined 1.79 degrees to the port side, the end of the No. 1 crane's jib must move to the starboard side by the 1.79 degrees obtained in (i) so that the hoisted cargo will be at the Established Position (Figure 4, Figure 7). Accordingly, we again obtain the jib's angle of elevation and swivel angle and, further, obtain the inclination angle when the cargo is suspended at the Established Position with the jib at this position.

Consequently, it is necessary to move the jib's end 1.49 meters laterally when looking from above as shown in Figure 4 and, simultaneously, to move it 0.58 meters downward so that it intersects with the 1.79-degree inclination angle line, as shown in Figure 7.

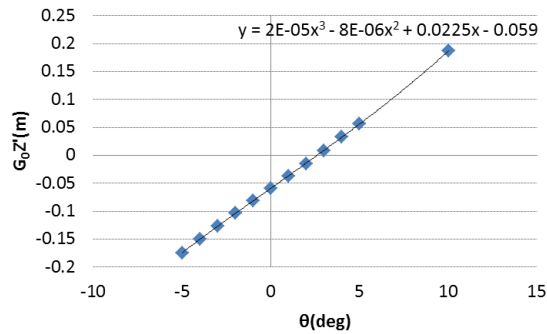
Figure 5 Righting Arm G_0Z' and its Approximation Formula

$G_0 Z'$, which we obtained by correcting the righting arm provided in the stability-related materials with Formula (3), and its approximation formula are shown in Figure 5.

$$\theta_3 = 6.93(\text{deg})$$

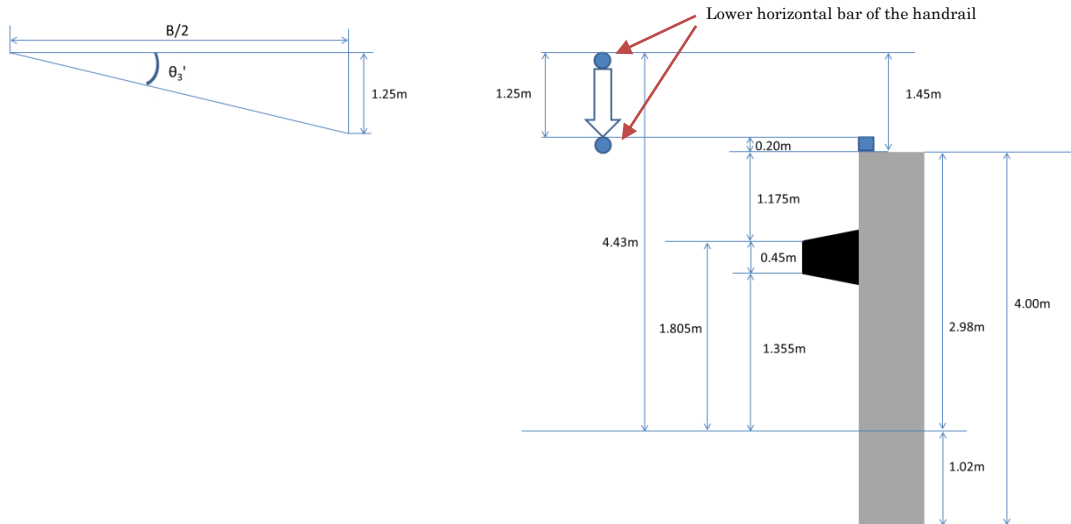
Figure 6 Downward Movement of the Handrail

The height from the ship's bottom to the relevant position of the handrail is provided in the Materials, and the difference between this height and the top of the bumper on the wharf is 1.25 meters (Figure 6). Accordingly, if the beam is expressed as B, θ_3' as a small angle is

$$\theta_3' = 7.06(\text{deg})$$

This value roughly matches with maximum inclination angle θ_3 generated when the fenders become separated that was obtained in (2).
